**Title:** Centennial Mural  
**Type:** Oil paint on cotton duck sailcloth  
**Artist:** Duard Marshall  
**Signature:** lower right of all panels, "Duard Marshall 1939"  
**Created:** 1939  
**Size:** 84" x 360"  
**Framed:** Frame has been fabricated, but is not present; mounted with wood collar and strips

(birthplace of Thomas Hart Benton). on-site visit to examine the named mural for conservation, cleaning and restoration. It is displayed at the Neosho Library. Examination was performed with available light, ultraviolet light and microscopic magnification. An aqueous and solvent-based cleaning test was performed. Please refer to this report for the condition in general.

**Title:** Rocketdyne Mural  
**Type:** Acrylic on masonite  
**Artist:** Lawrence Sanchez, Jr.  
**Signature:** bottom right, "L. Sanchez 1963"  
**Created:** 1963  
**Size:** 536" x 107"  
**Framed:** 1" traditional profile, non-structural, medium-brown

Neosho, MO (birthplace of Thomas Hart Benton), on-site visit to examine a mural displayed on a wall in the science wing of Davidson Hall at Crowder College for conservation. Examination was performed with available light, ultraviolet light and microscopic ma

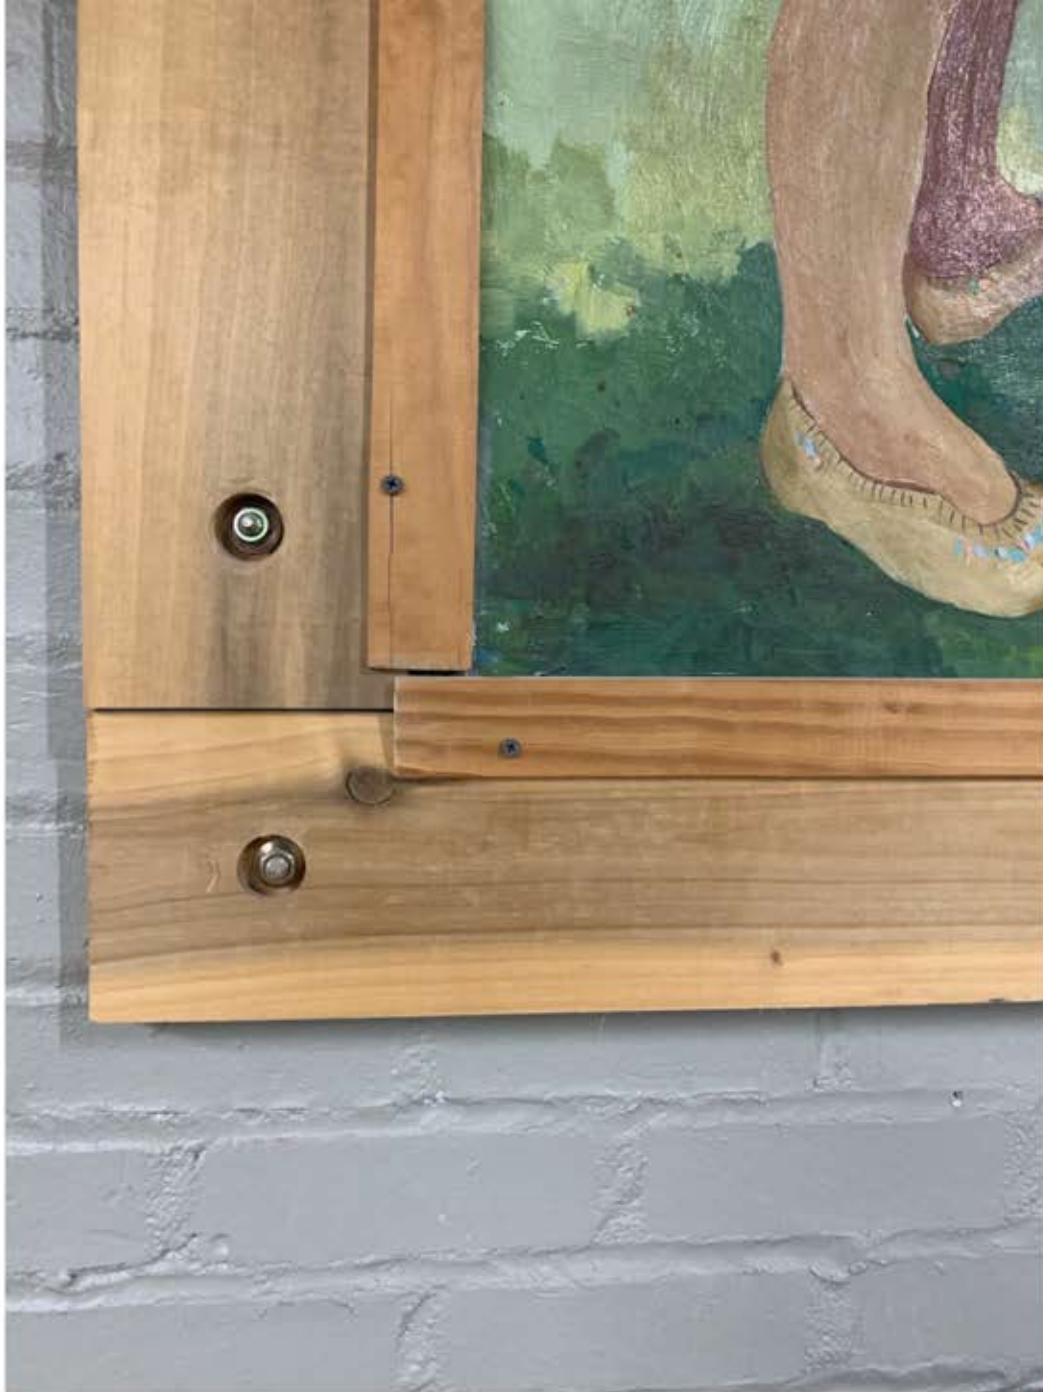
Detail of 2"x6" wood collar and strips used to mount mural to wall

- We advise the Arts Council to engage local help of two men on two 20' foot ladders to dismantle the inner wood strips holding the mural onto the 2"x6" collar and bring the mural to floor level Remove the mural from the wall and reinstall the mural after restoration is complete

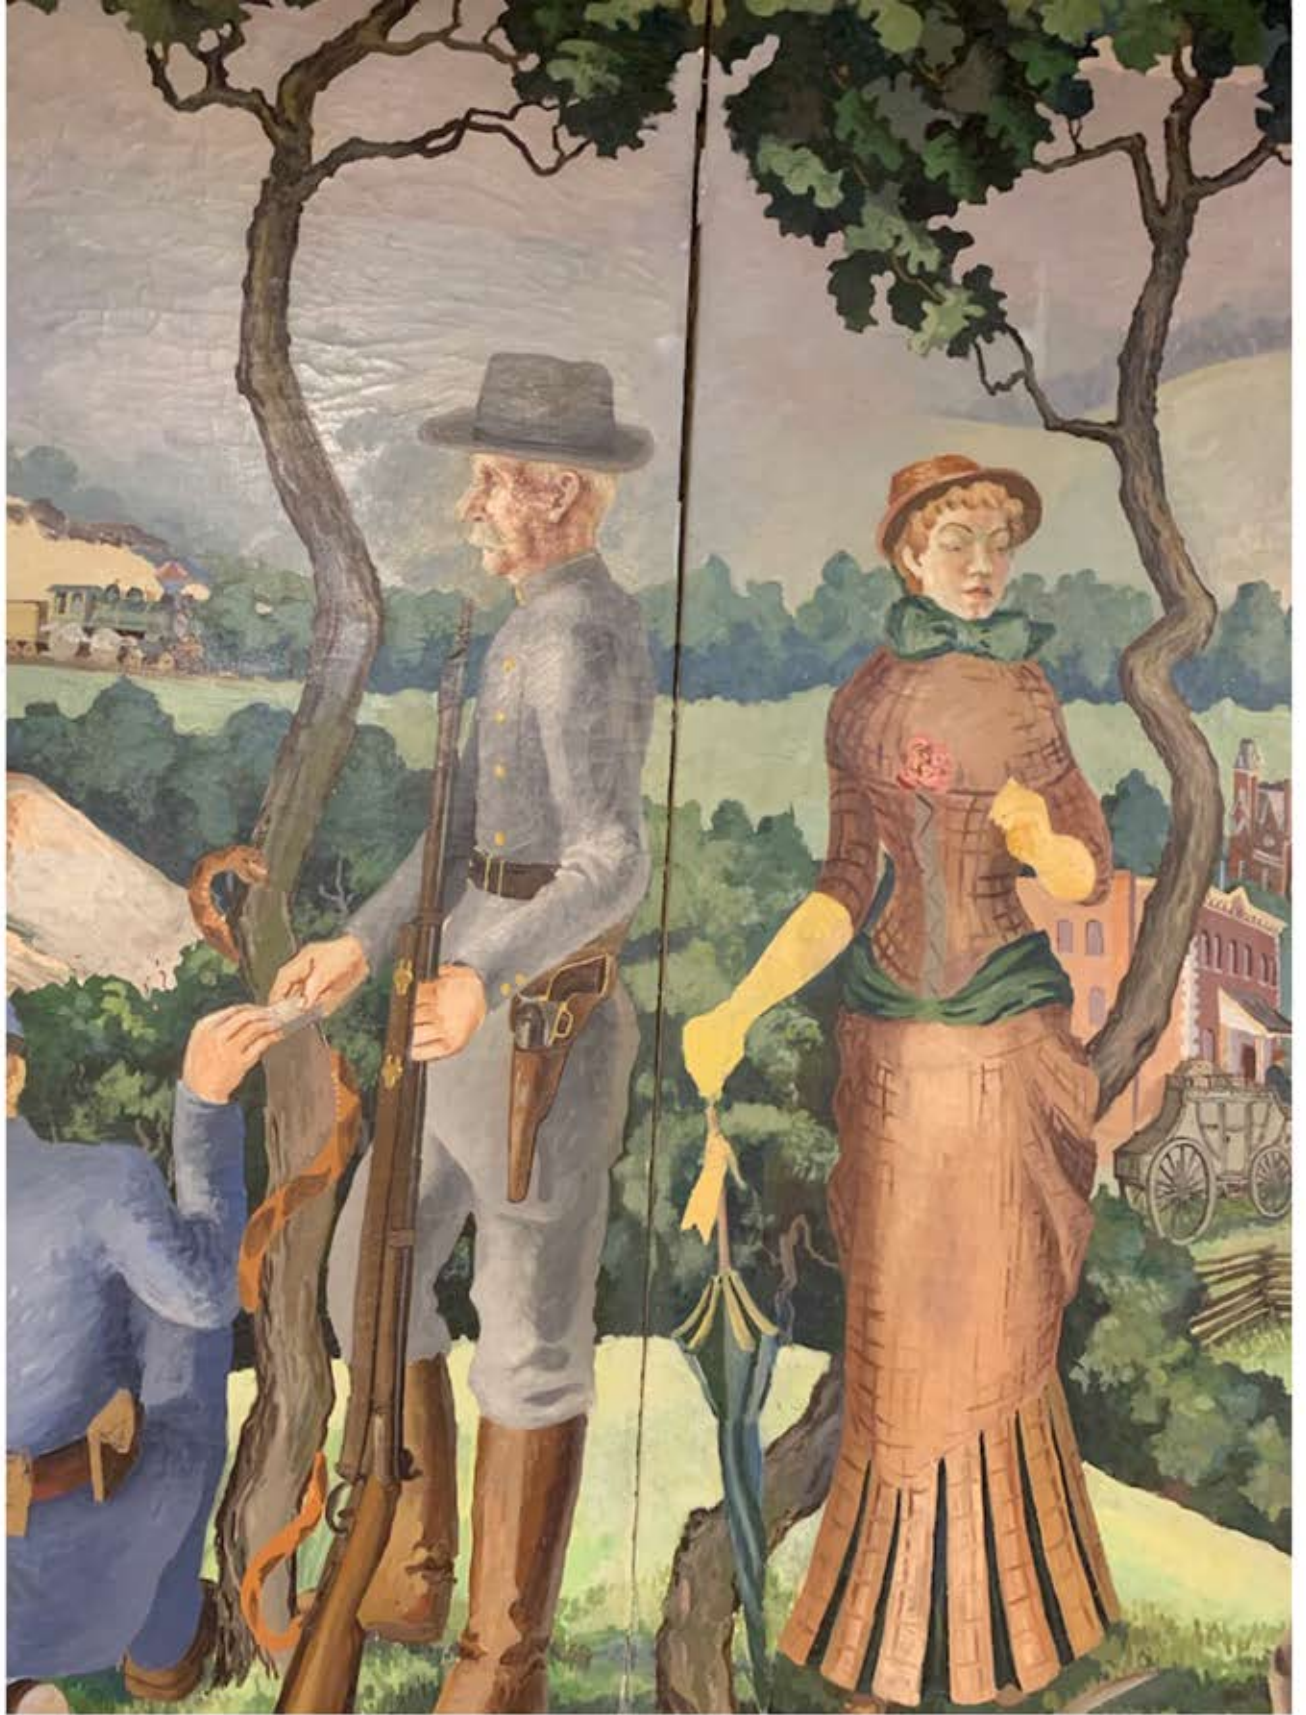
There are losses around the seams where the canvases were originally butted up against each other and filled; these losses are uneven, which creates visible gaps and disfigures the overall presentation. There are two staples in the third panel. These staples do not appear to have a structural purpose and are presumed to be the result of vandalism.

Visible gap between panel 1 and panel 2

- Clean panels with tested tri-sodium meta-silicate or appropriate surfactant and clear with alcohol
- Smooth and level uneven edges where panels seams join

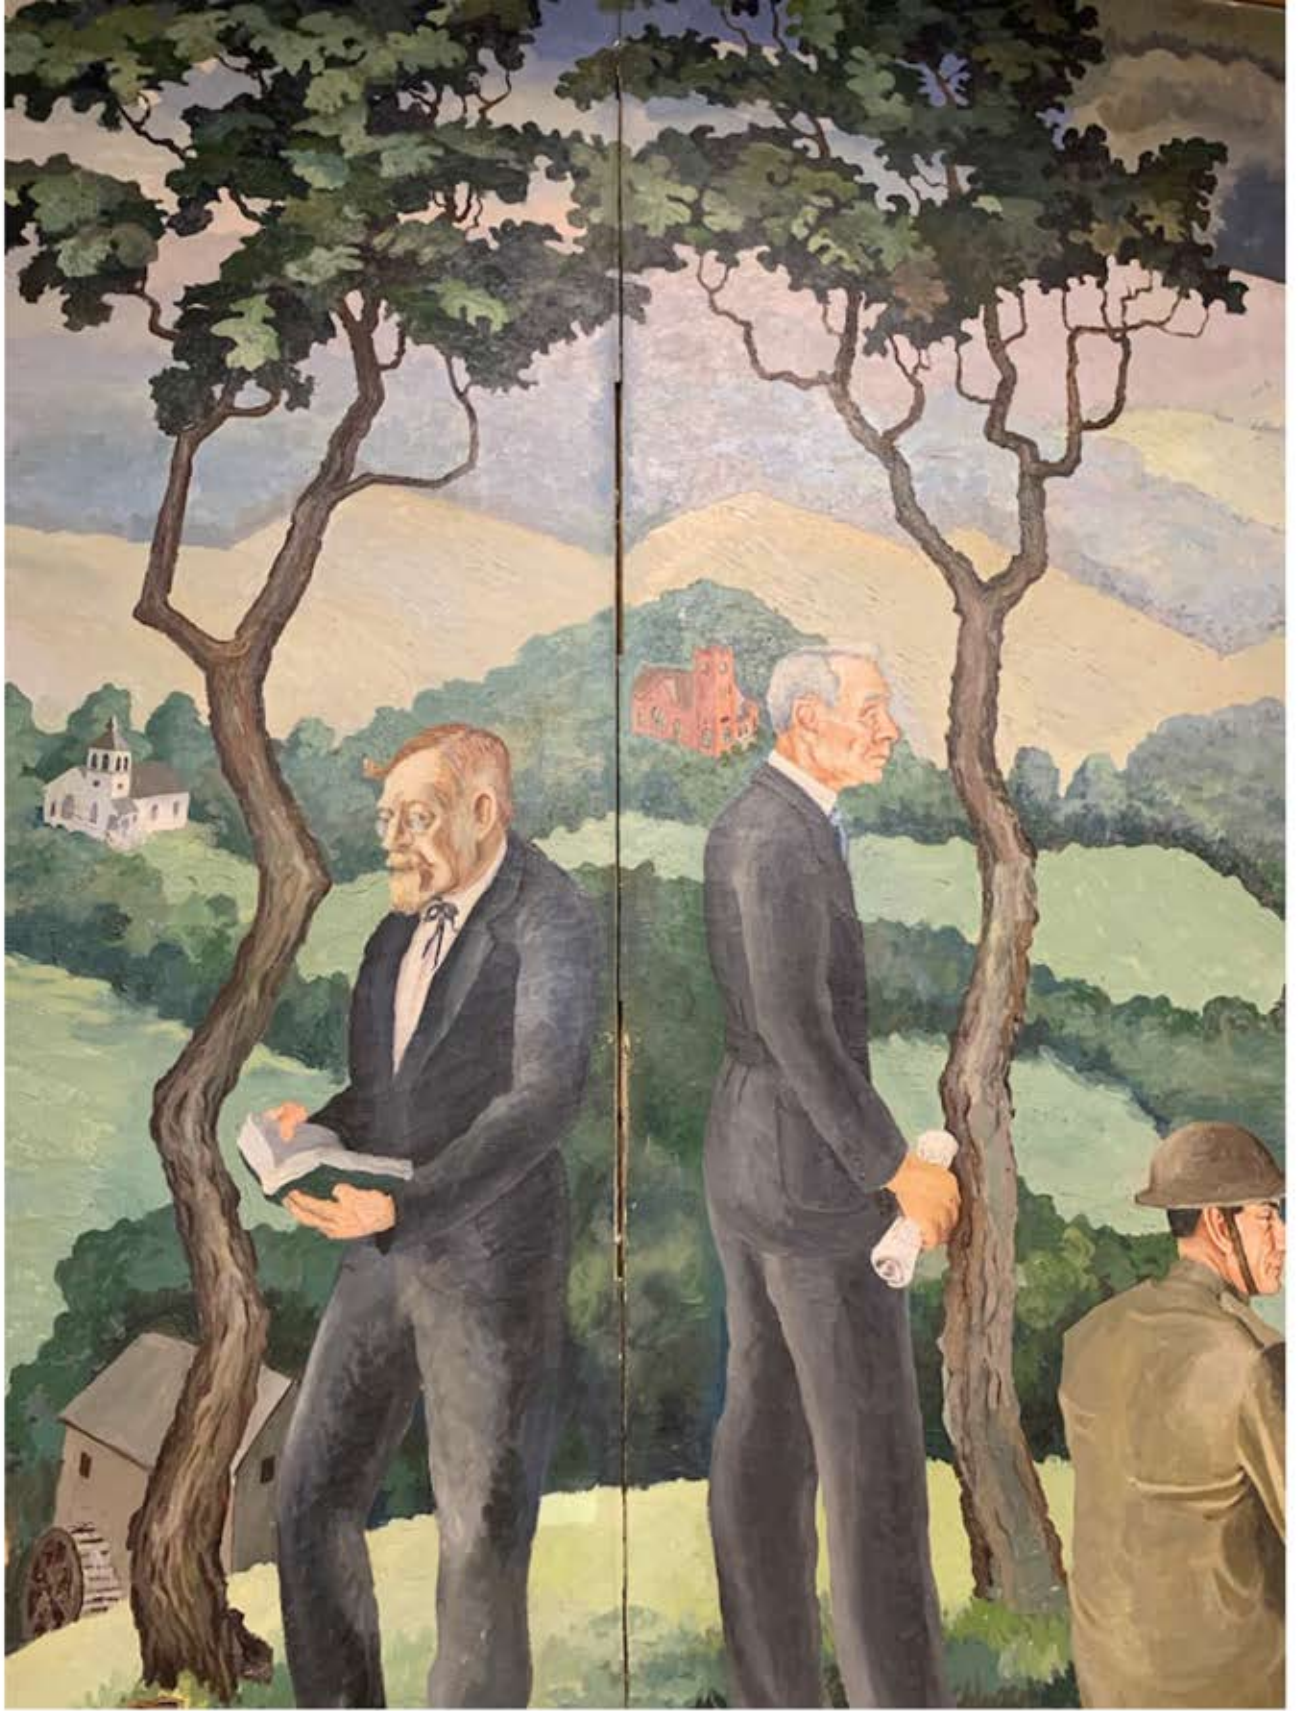
Visible gap between panel 2 and panel 3

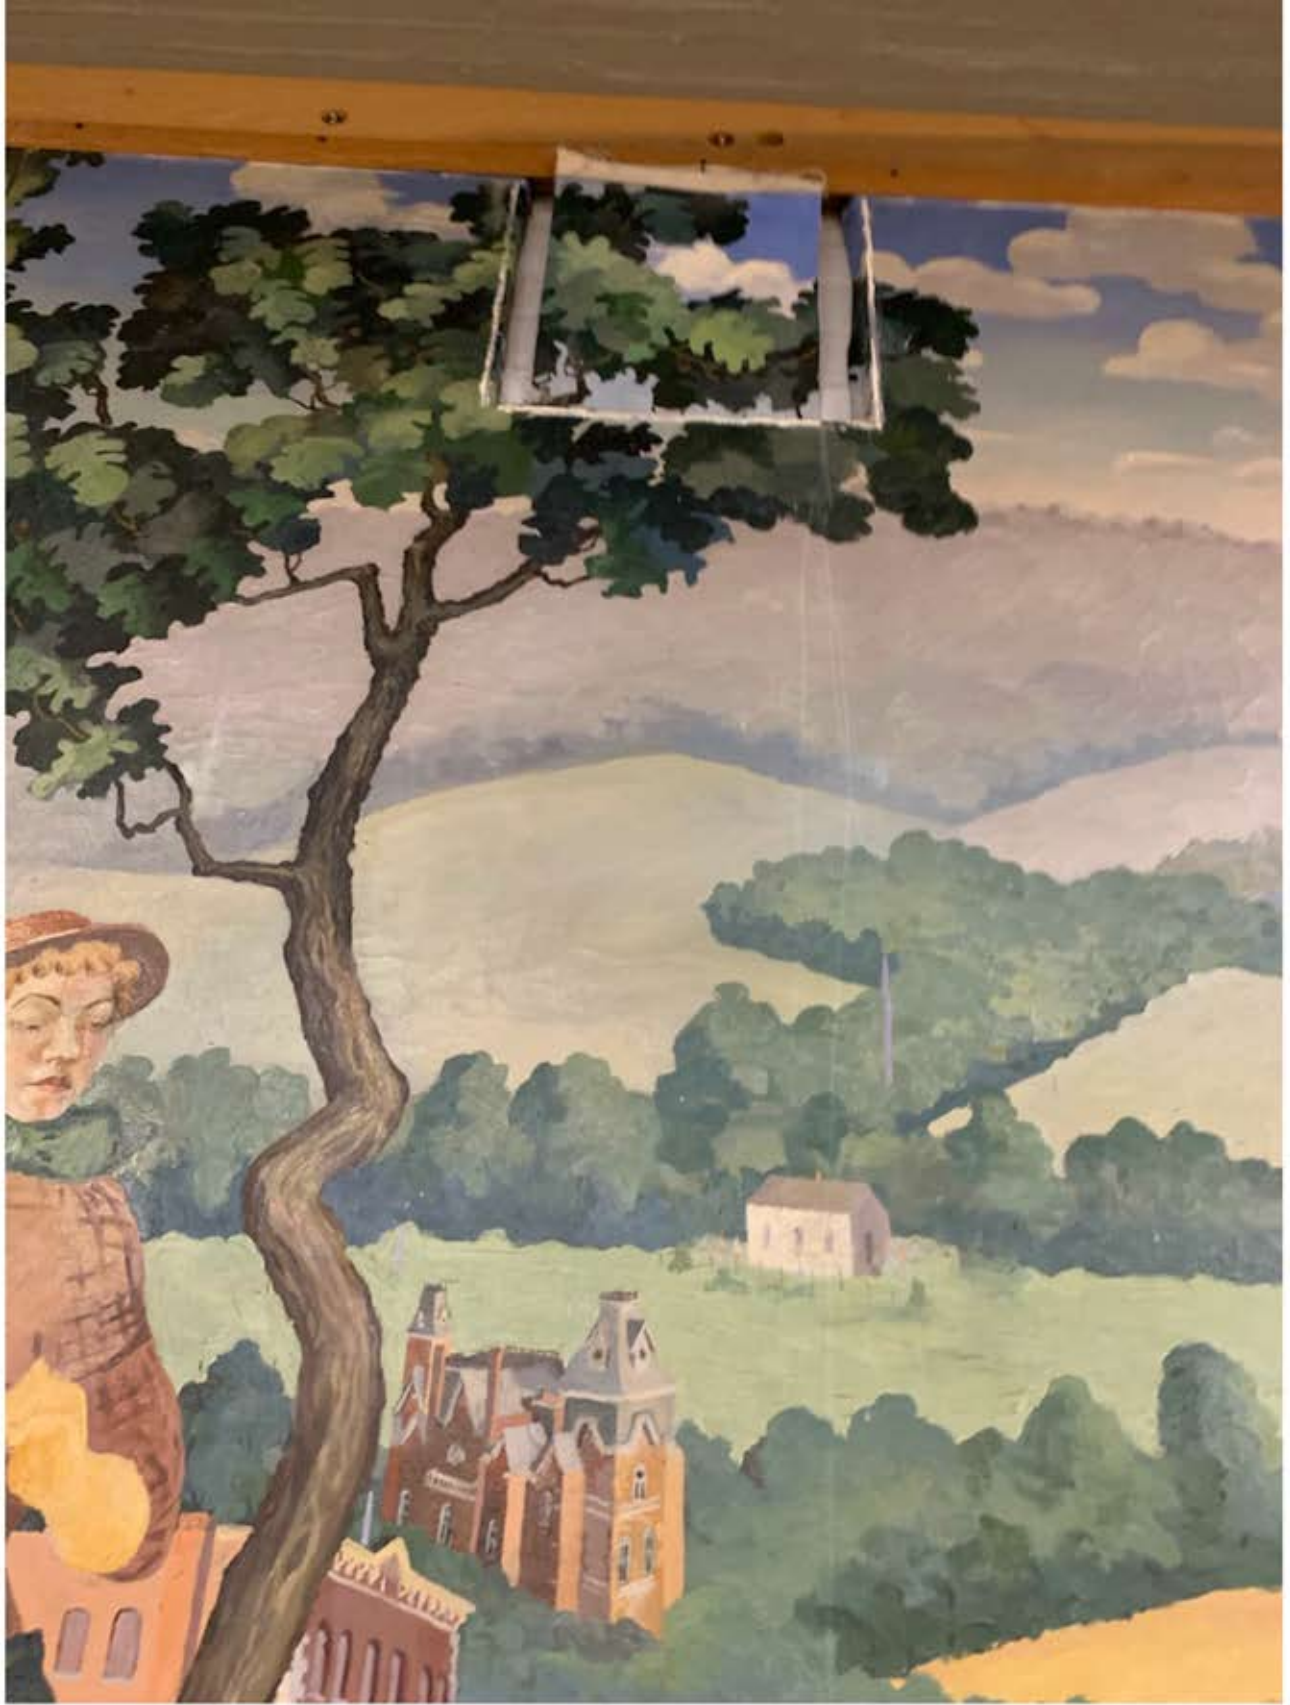
The center panel has a 14" square cut out at the top left where an air vent was installed in a previous location. The cut out portion has been retained and is displayed in place but not attached. There is evidence of water damage in the form of long rills originating from the cut out. Visible in raking light are water rills that run the length of the mural.

Cut out section from previous installation; note difference in color between cut out section and the rest of the mural - indicative of airborne grime accumulation

- Tarp an area close to the site
- Treat mural panels individually at ground level
- Structurally re-attach the cut out portion of second panel fill and inpaint to match the surround

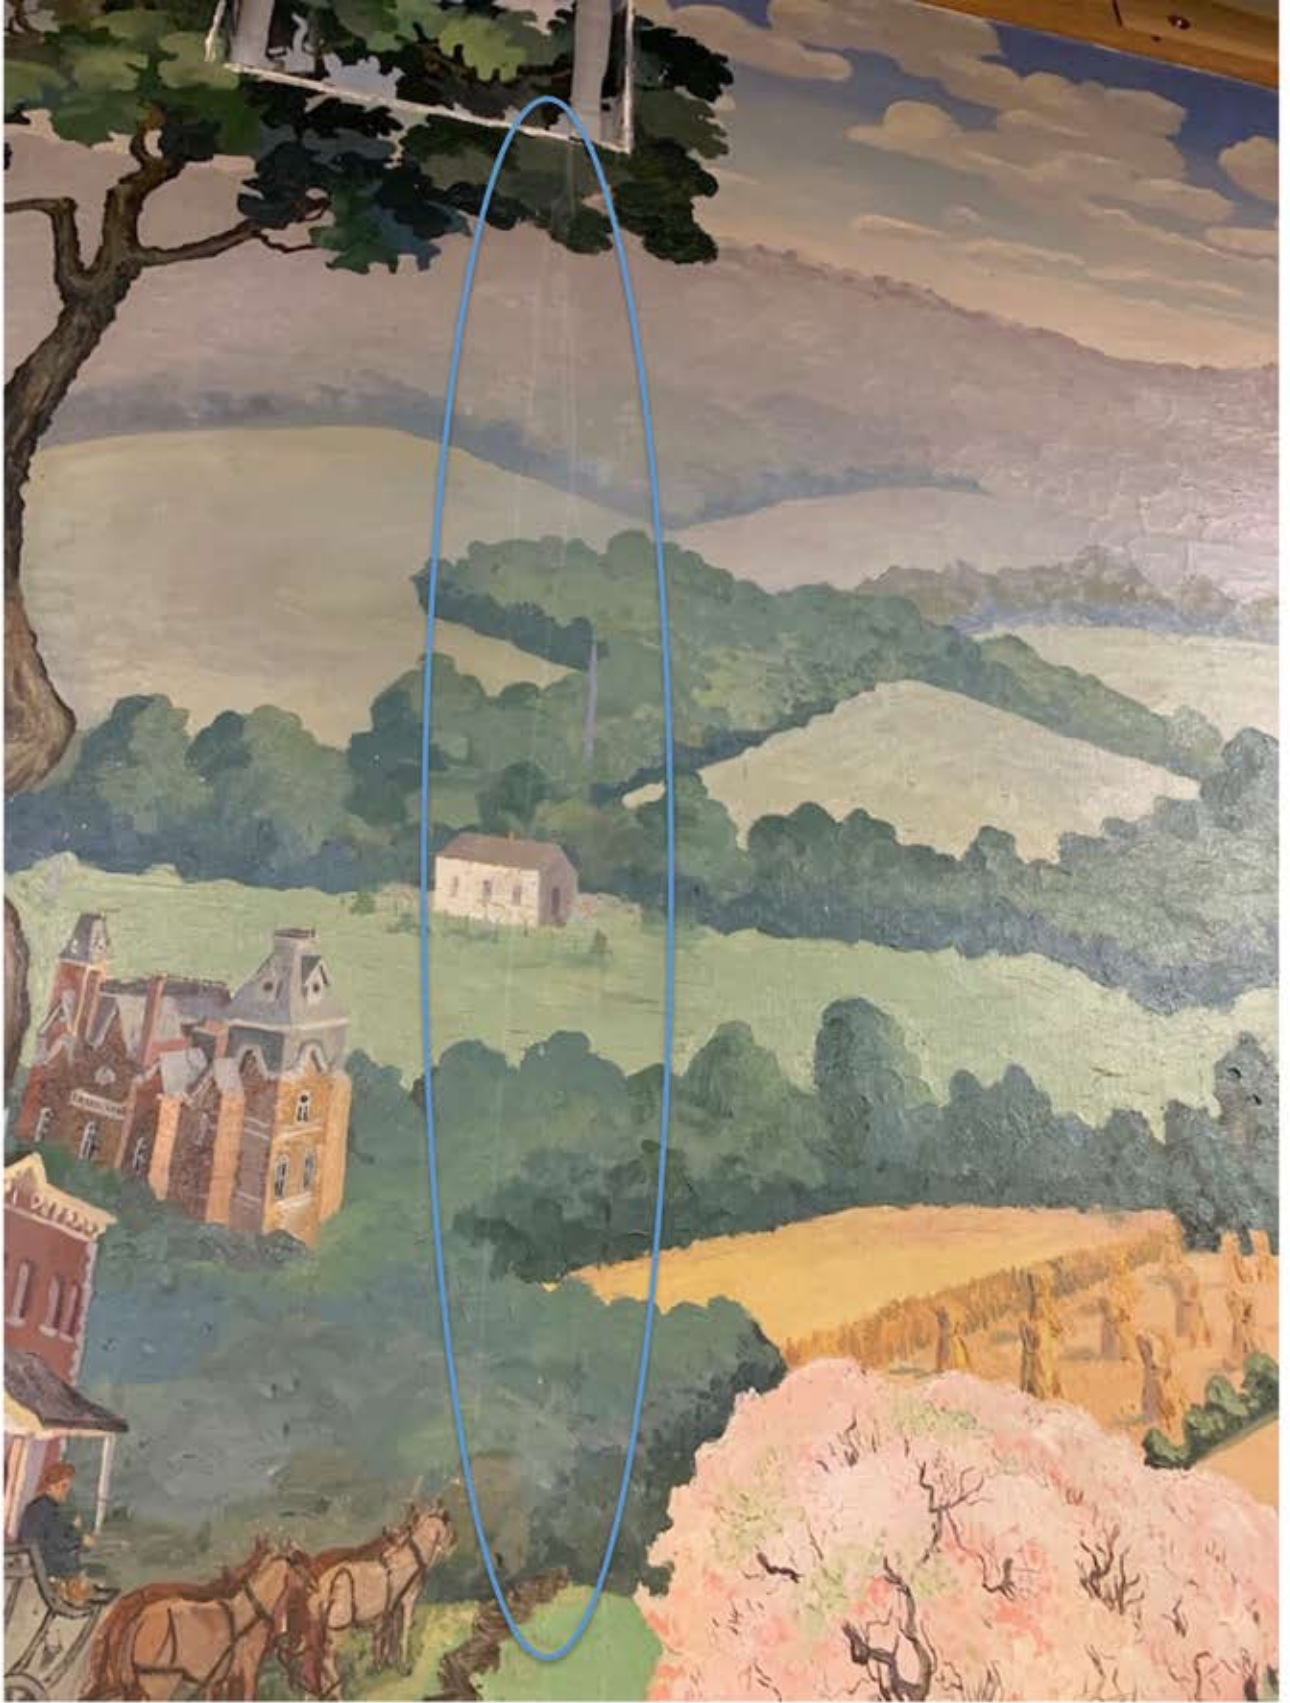
Water rills originating from cut out section, which previously housed an air vent

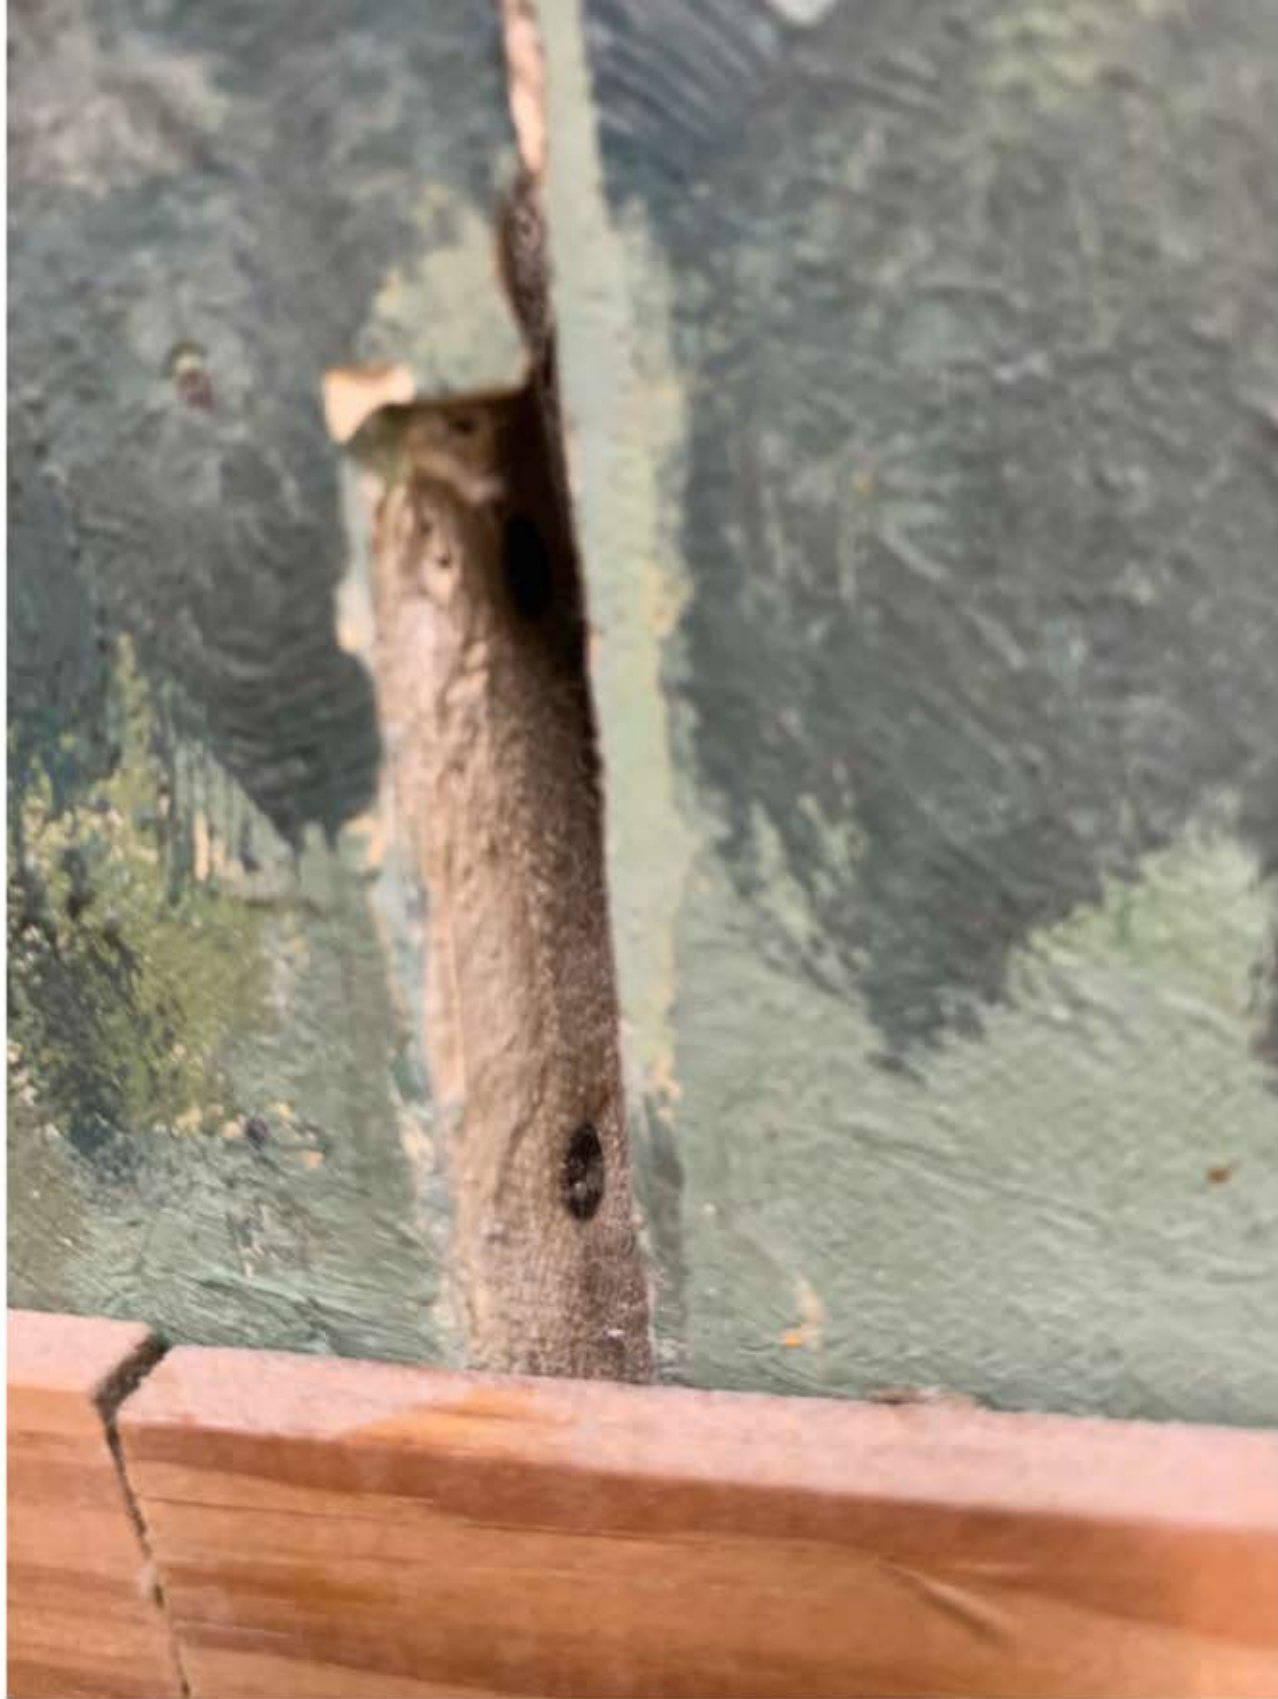
The mural is comprised of three separate canvas panels, each approximately 126", tacked onto custom-built strainers with foundry tacks. There does not appear to be a central support installed as the mural billows to the touch. The strainers are slightly bowing in the center where the panels meet, creating a visible gap between panels. The undulating billowing effect may be a structural issue due to the lack of central supports or cross bars. The canvases are collared in 2"x6" wood boards with 1" wood strips screwed into overlapping the edges and installed onto a painted brick wall in the main library. The lighting is insufficient to light the mural.

Detail of gap created by bowing strainers and uneven seam

- Remove staples from the second panel
- Install crossbars from the verso (if necessary) to counteract the bowing of the seams and add structural support

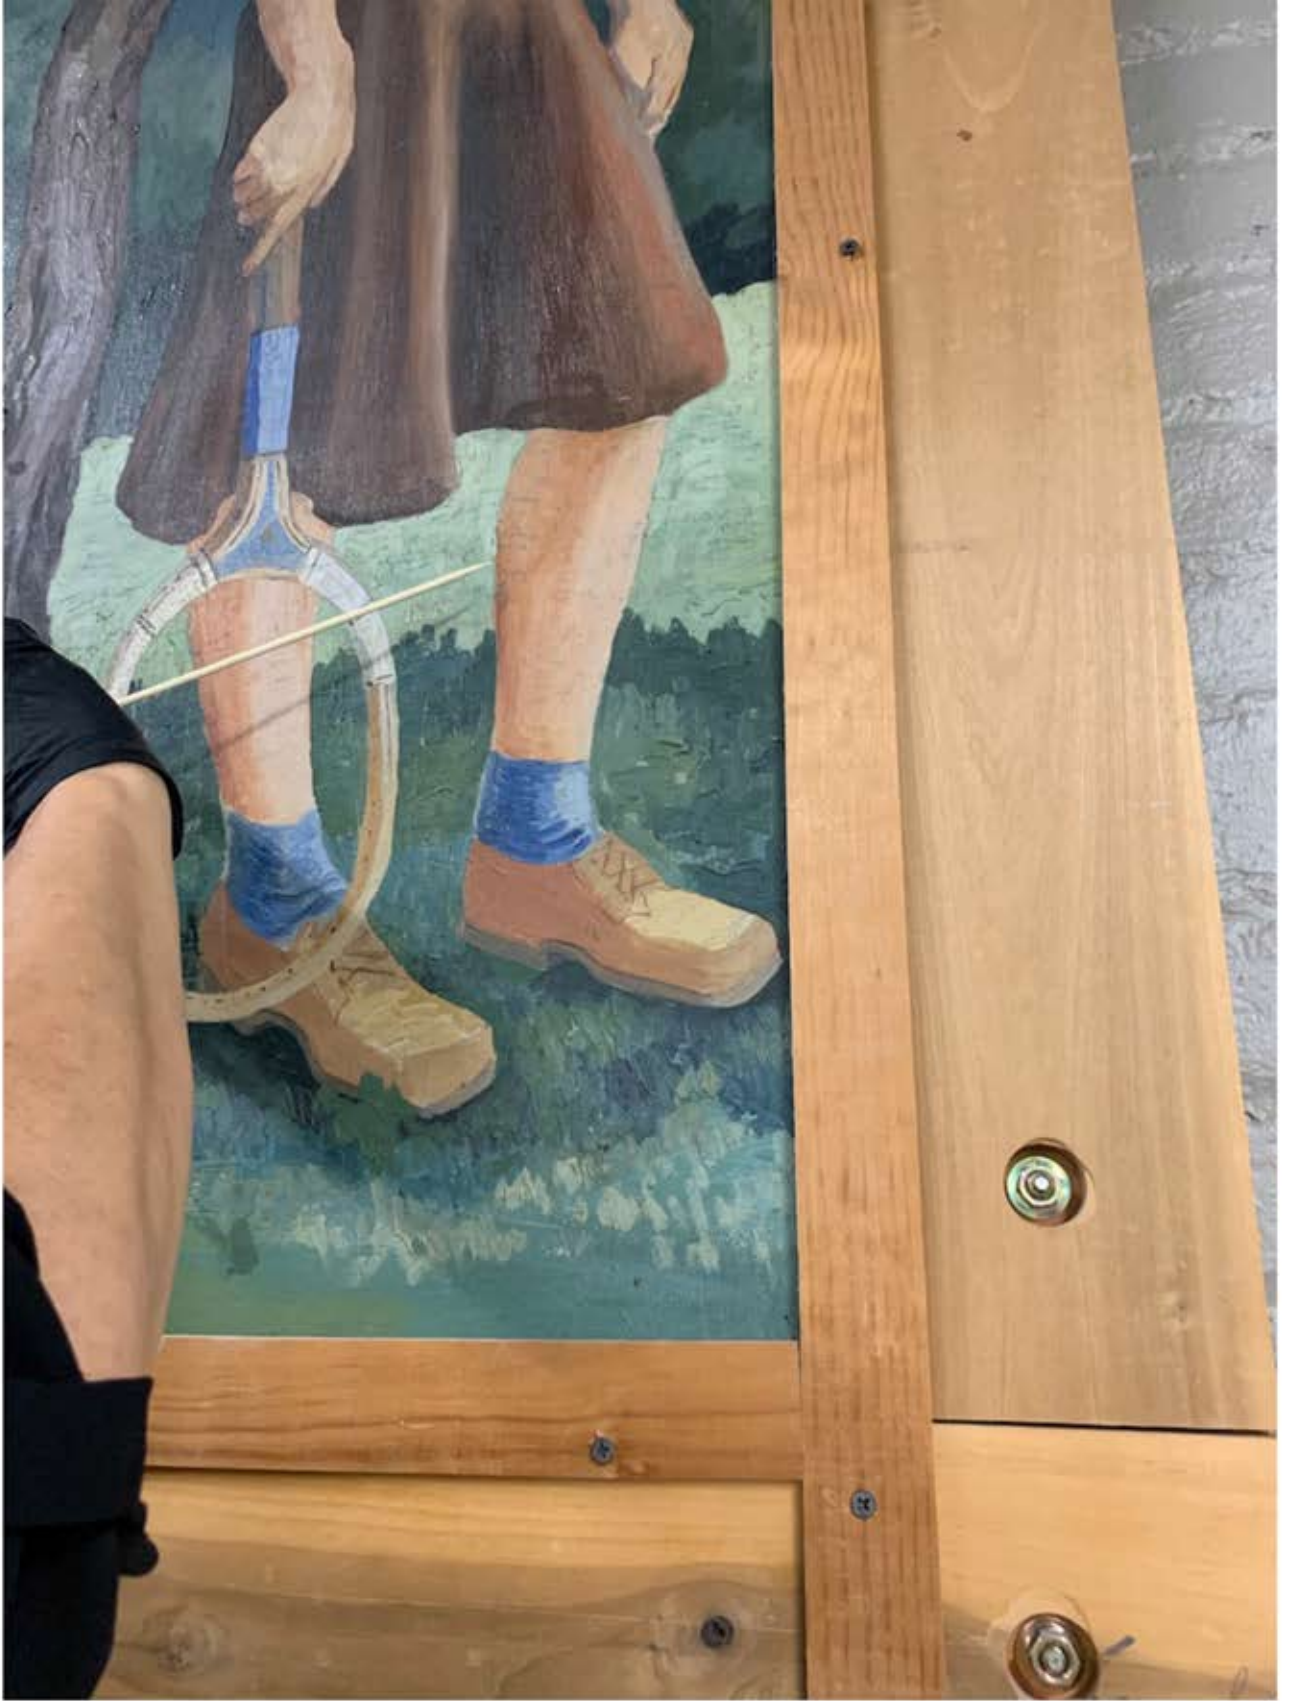
Test area before cleaning test is administered

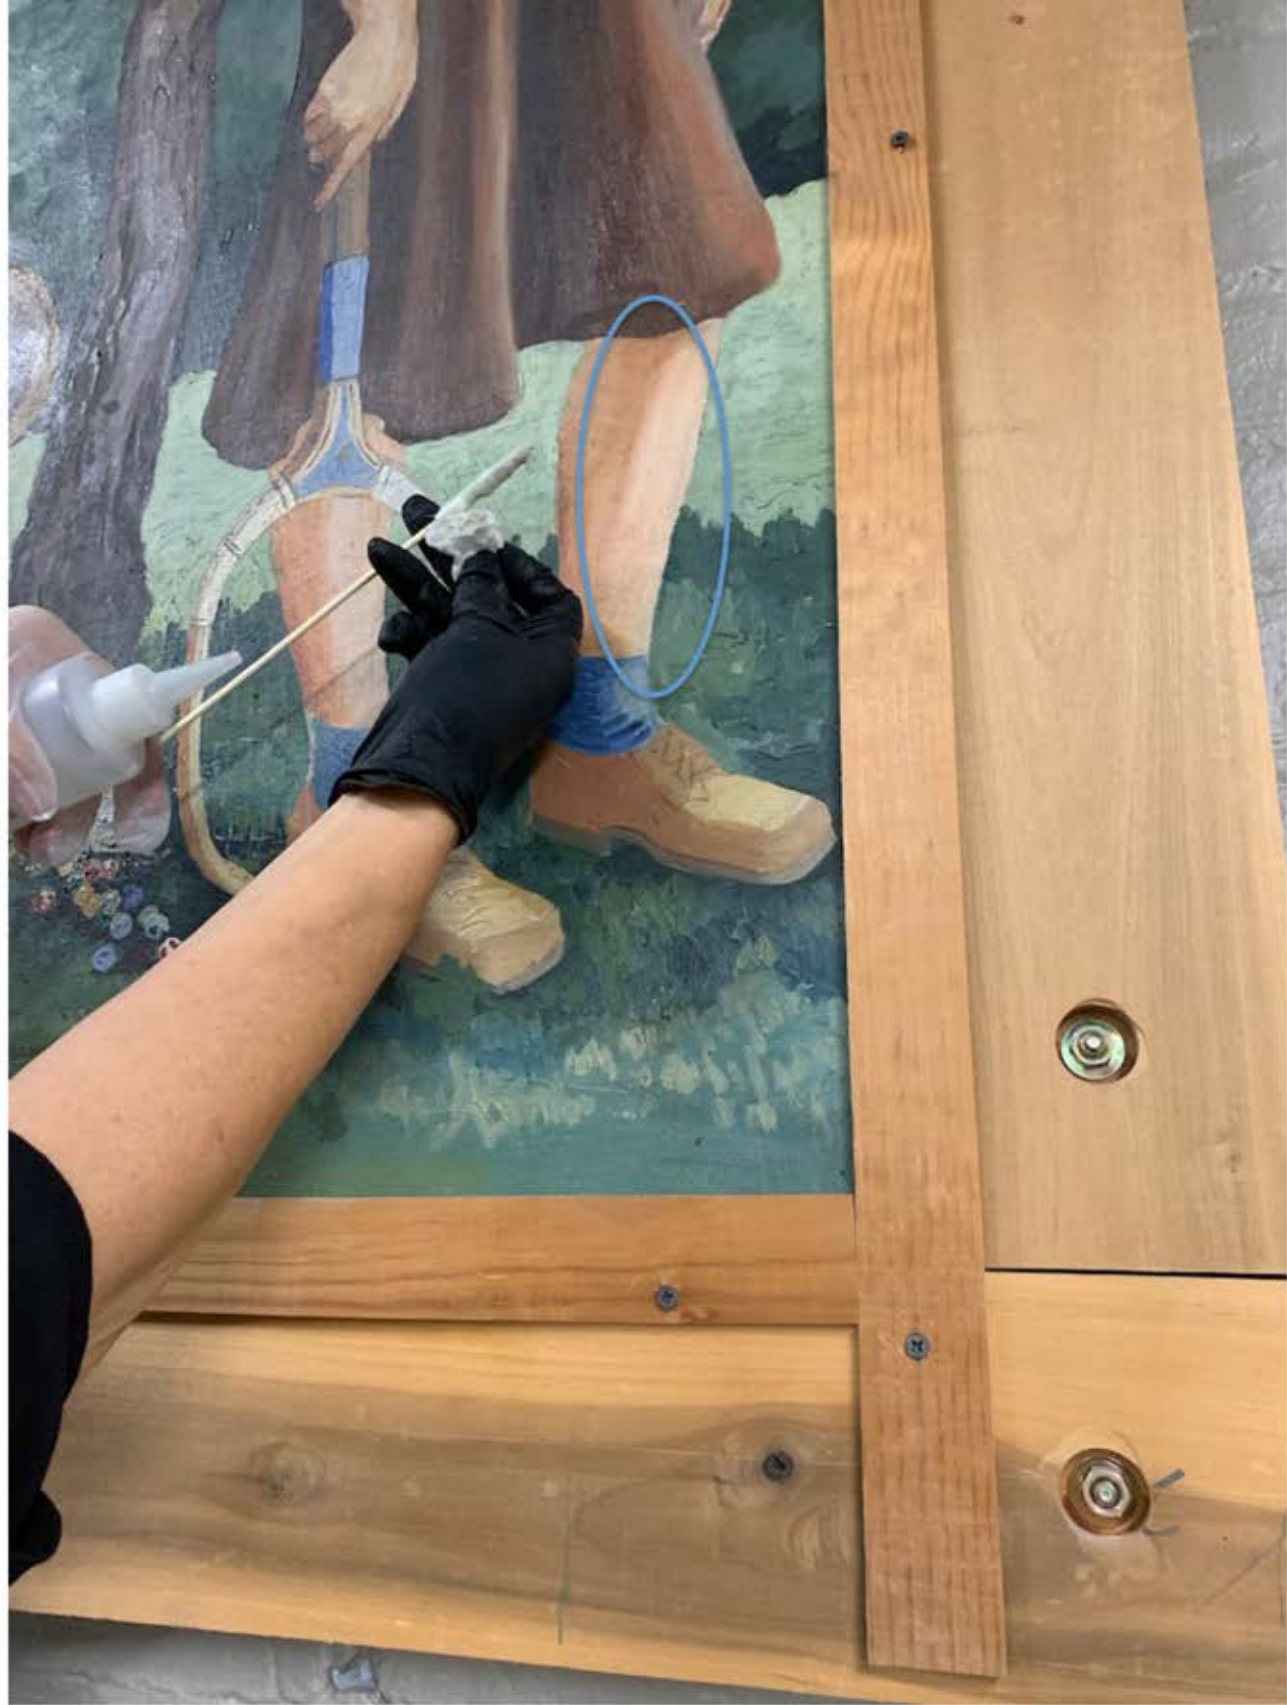
The paint is heavy impasto oil paint with no varnish present. There is heavy accumulation of dust and airborne grime. Cleaning tests with tri-sodium-meta-silicate, cleared with alcohol, also revealed a heavy layer of soot, likely from coal-fired furnaces.

Test are after cleaning test is administered

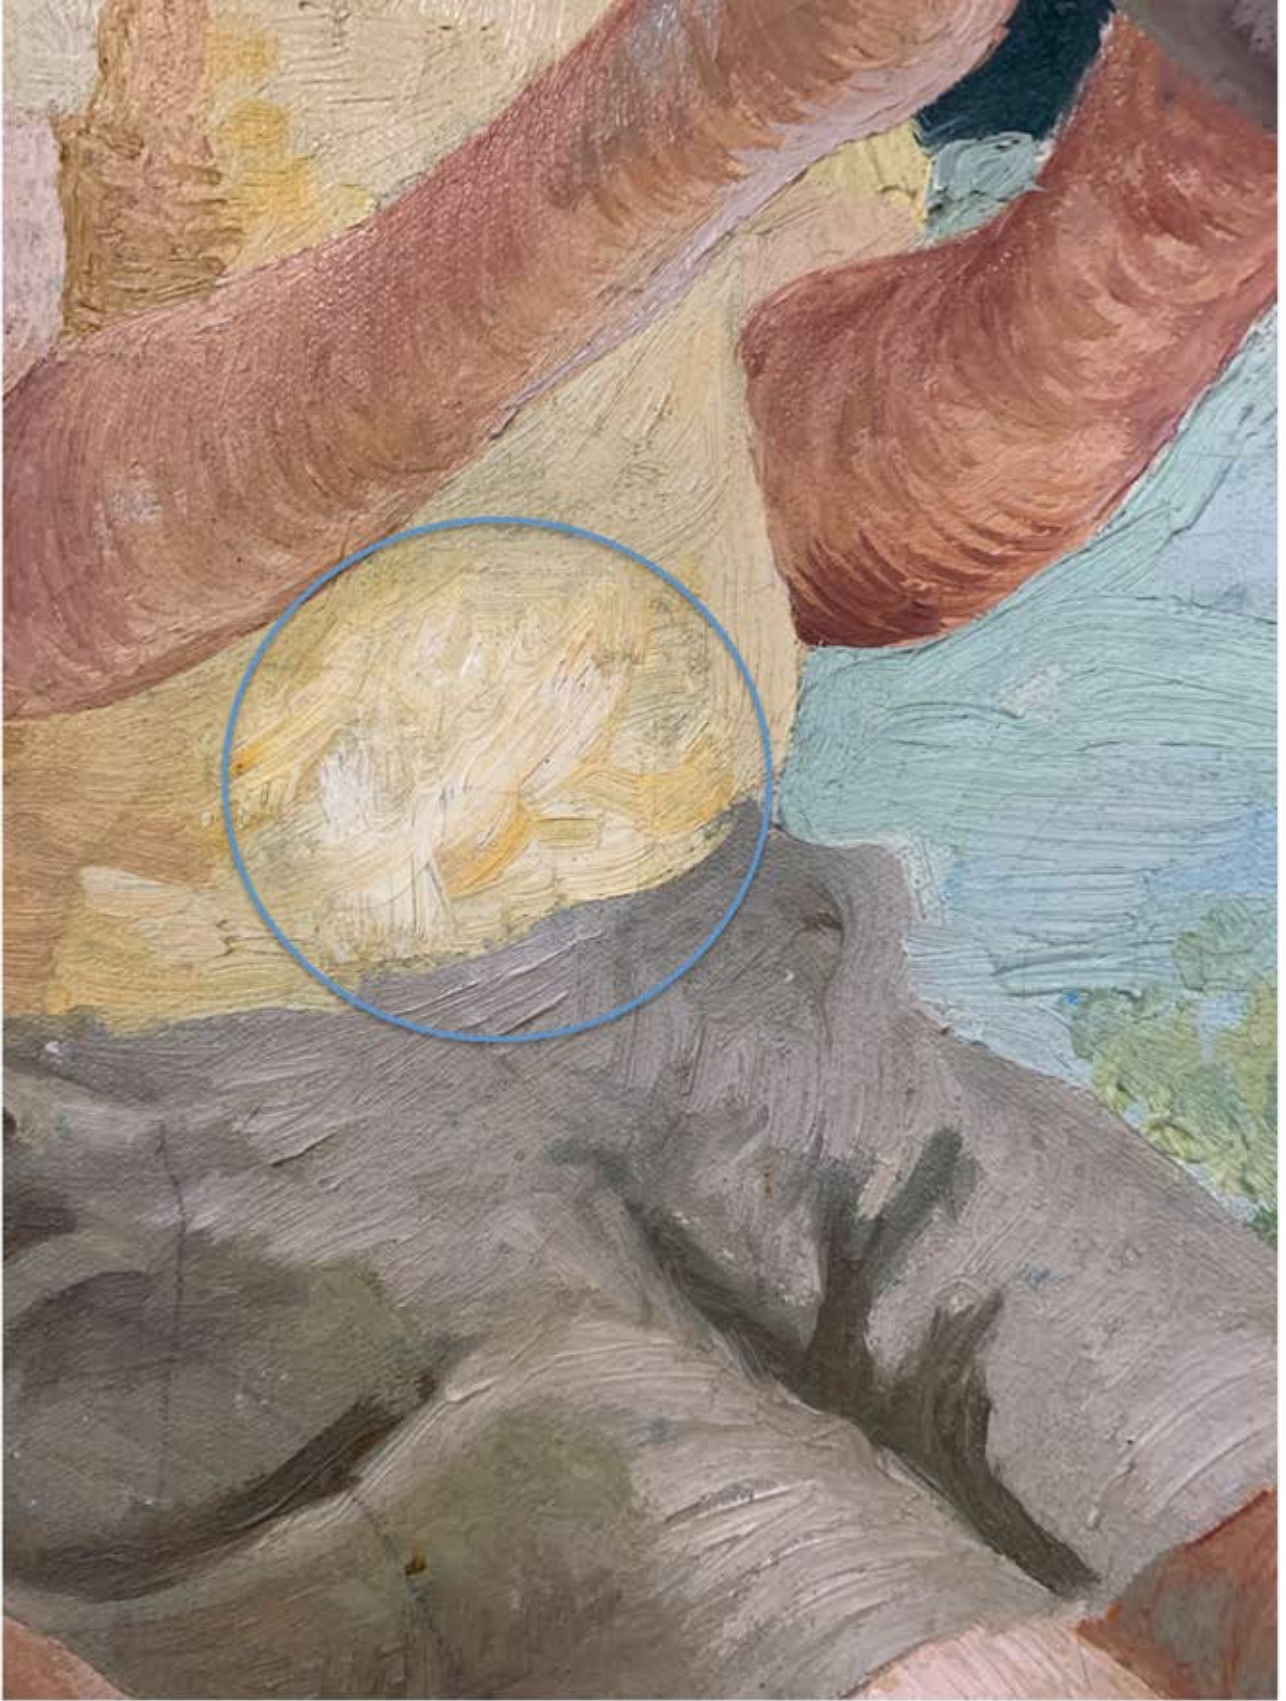
Another test area after cleaning test is administered

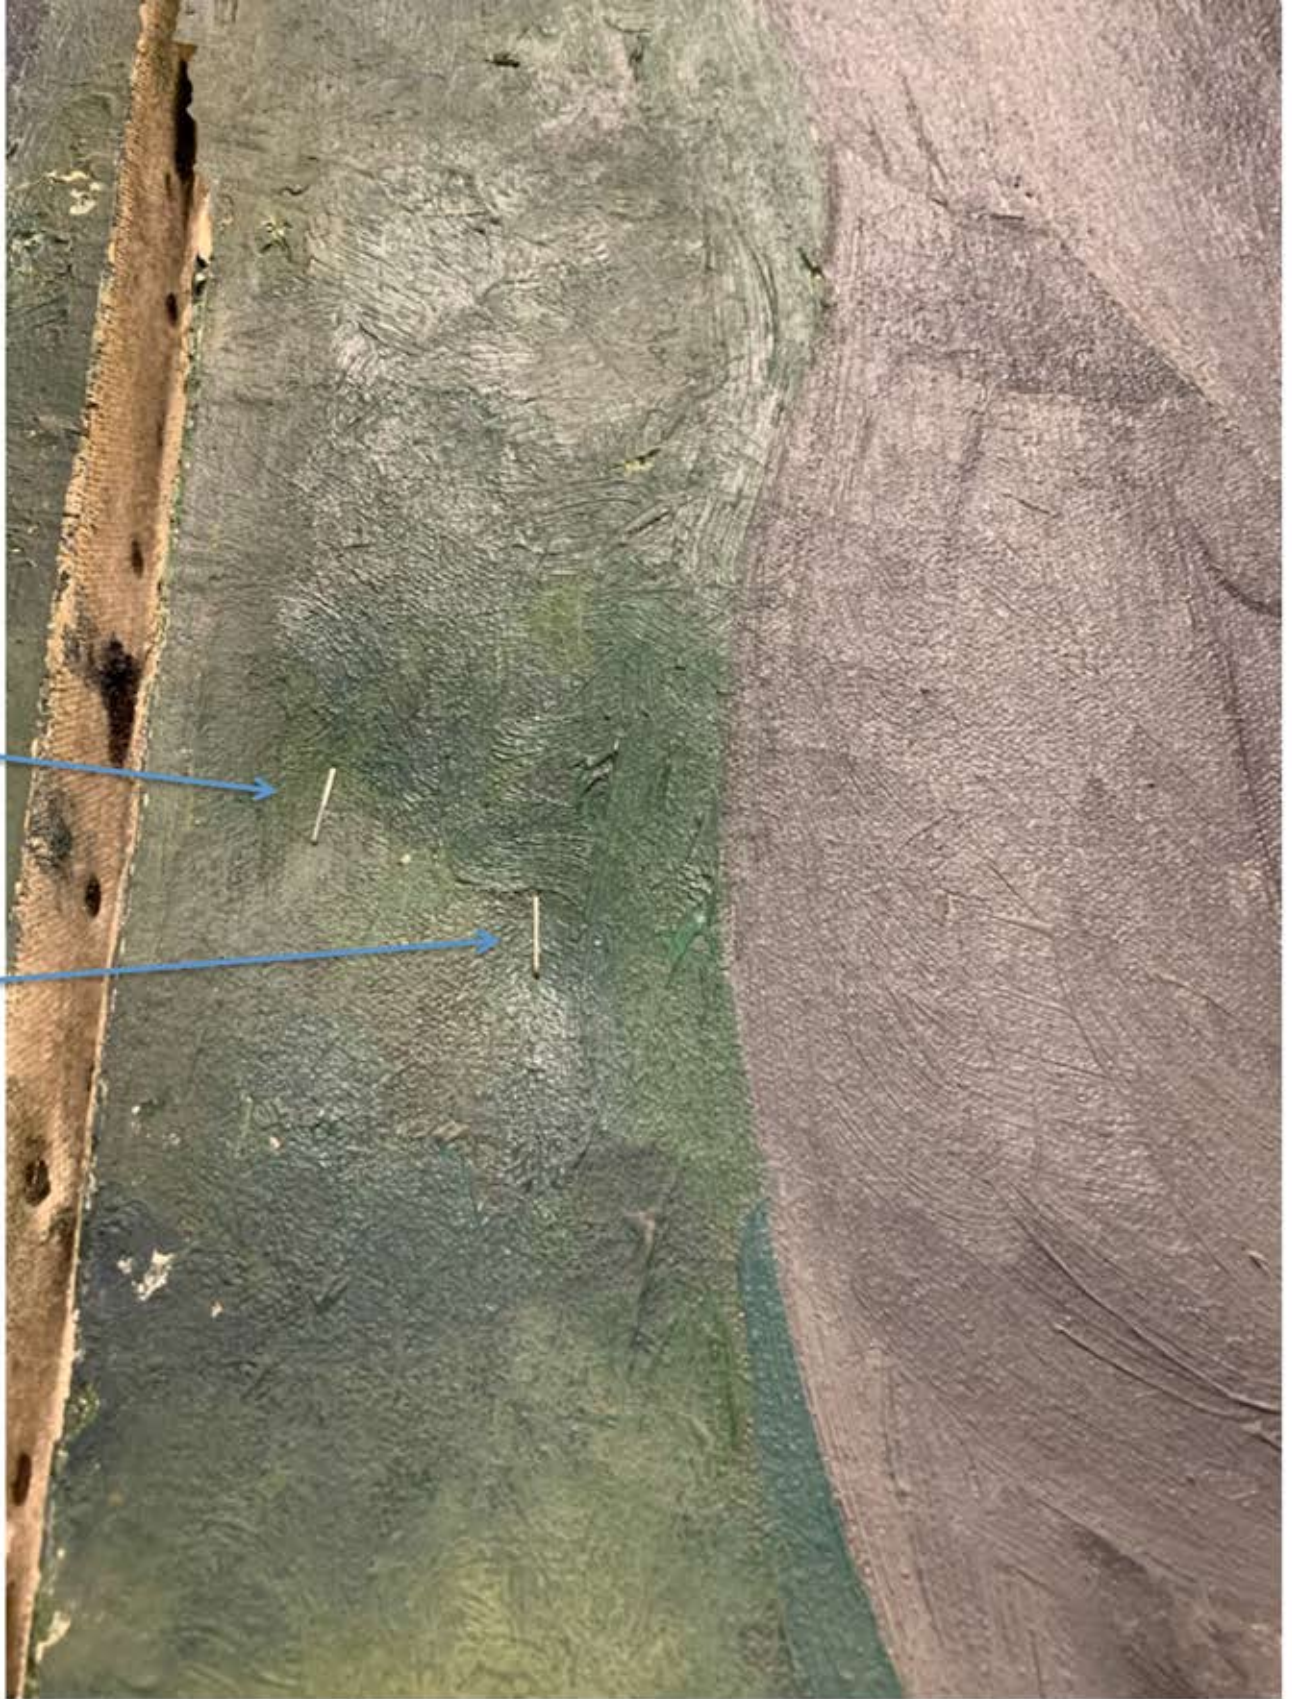
Staples in third panel
