**Title:** Centennial Mural  
**Type:** Oil paint on cotton duck sailcloth  
**Artist:** Duard Marshall  
**Signature:** lower right of all panels, "Duard Marshall 1939"  
**Created:** 1939  
**Size:** 84" x 360"  
**Framed:** Frame has been fabricated, but is not present; mounted with wood collar and strips

(birthplace of Thomas Hart Benton). on-site visit to examine the named mural for conservation, cleaning and restoration. It is displayed at the Neosho Library. Examination was performed with available light, ultraviolet light and microscopic magnification. An aqueous and solvent-based cleaning test was performed. Please refer to this report for the condition in general.

**Title:** Rocketdyne Mural  
**Type:** Acrylic on masonite  
**Artist:** Lawrence Sanchez, Jr.  
**Signature:** bottom right, "L. Sanchez 1963"  
**Created:** 1963  
**Size:** 536" x 107"  
**Framed:** 1" traditional profile, non-structural, medium-brown

Neosho, MO (birthplace of Thomas Hart Benton), on-site visit to examine a mural displayed on a wall in the science wing of Davidson Hall at Crowder College for conservation. Examination was performed with available light, ultraviolet light and microscopic ma

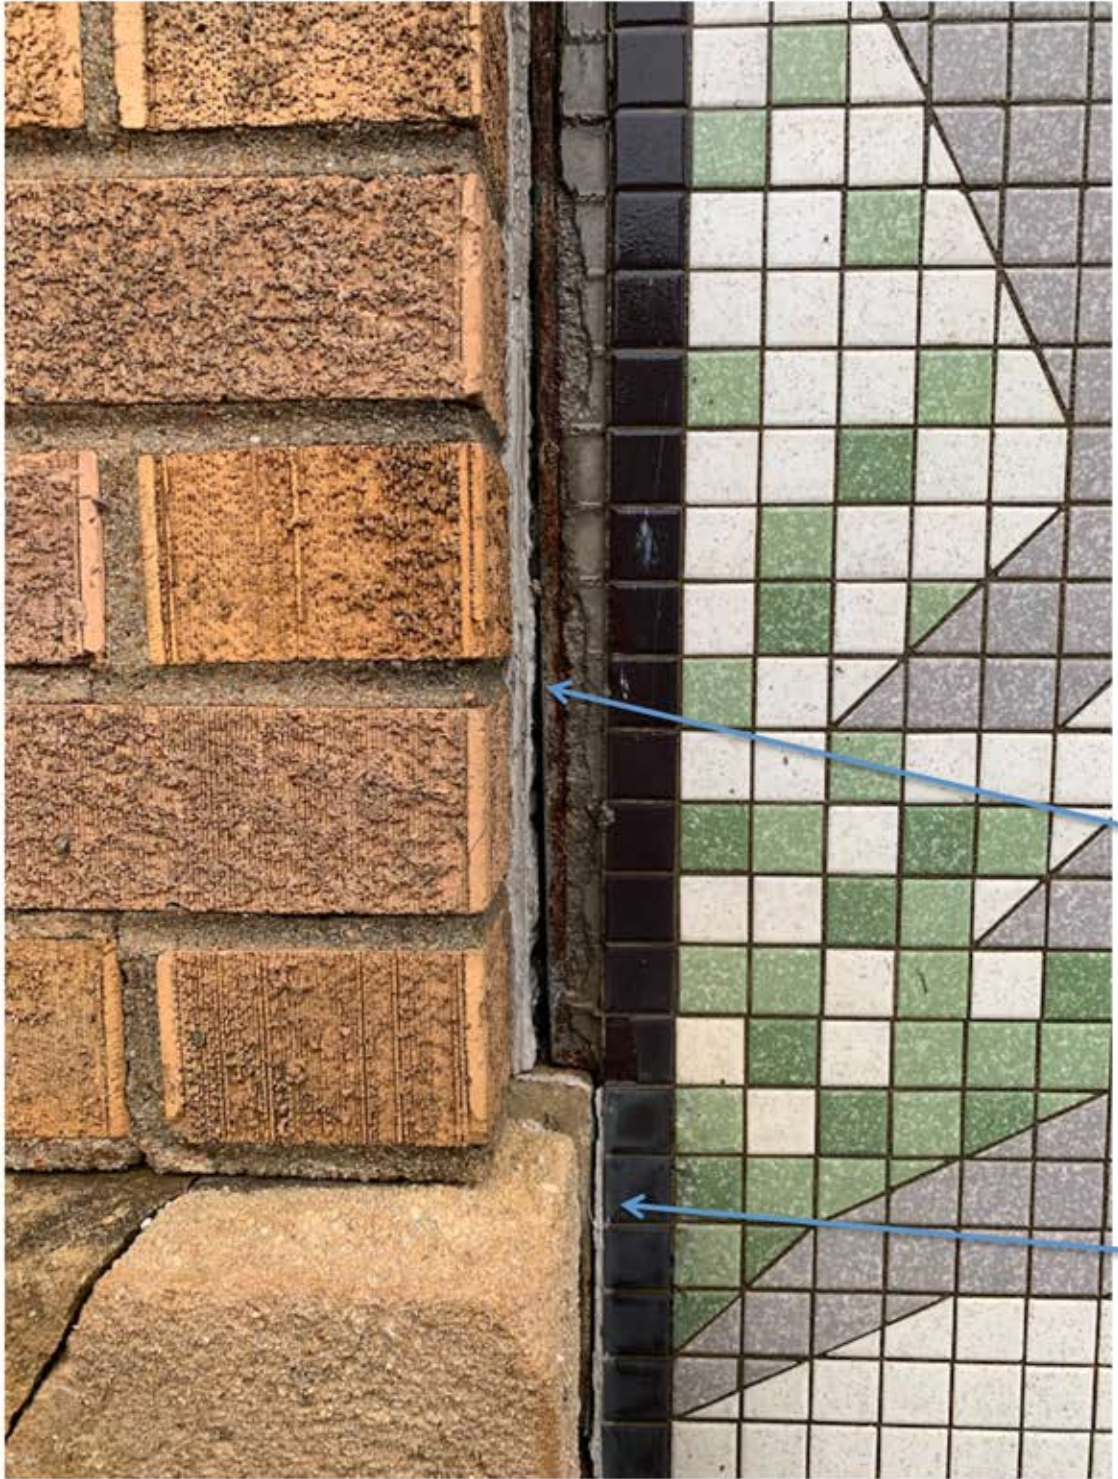
The mural is comprised of 1" ceramic tiles adhered to an exterior wall with mortar. Cracks have formed in the mortar and in some of the tiles, possibly as a result of water damage behind the mortar and/or structural issues with the building. The mural appears to no longer be in plane, again possibly as a result of structural issues with the building. The mortar is discolored and crumbling in multiple areas causing the tile to delaminate and fall to the ground.

*Seal of tile to brick wall is broken and not water tight, tiles are delaminating*

- We advise Neosho Arts Council to engage a local structural engineer or contractor to inspect the building for structural integrity and water damage
- Restoration of the mural is not advised until building and wall have been cleared
- Reproduce missing tiles with new tiles custom-fired to match, depending on availability
- Remove built up grime and mortar from areas where tiles have been lost or removed
- Clean mural with an ionic surfactant
- Remove crumbling grout from the mosaic and repoint and fill losses
- Reinstall missing tile
- Seal grout and wax the mural

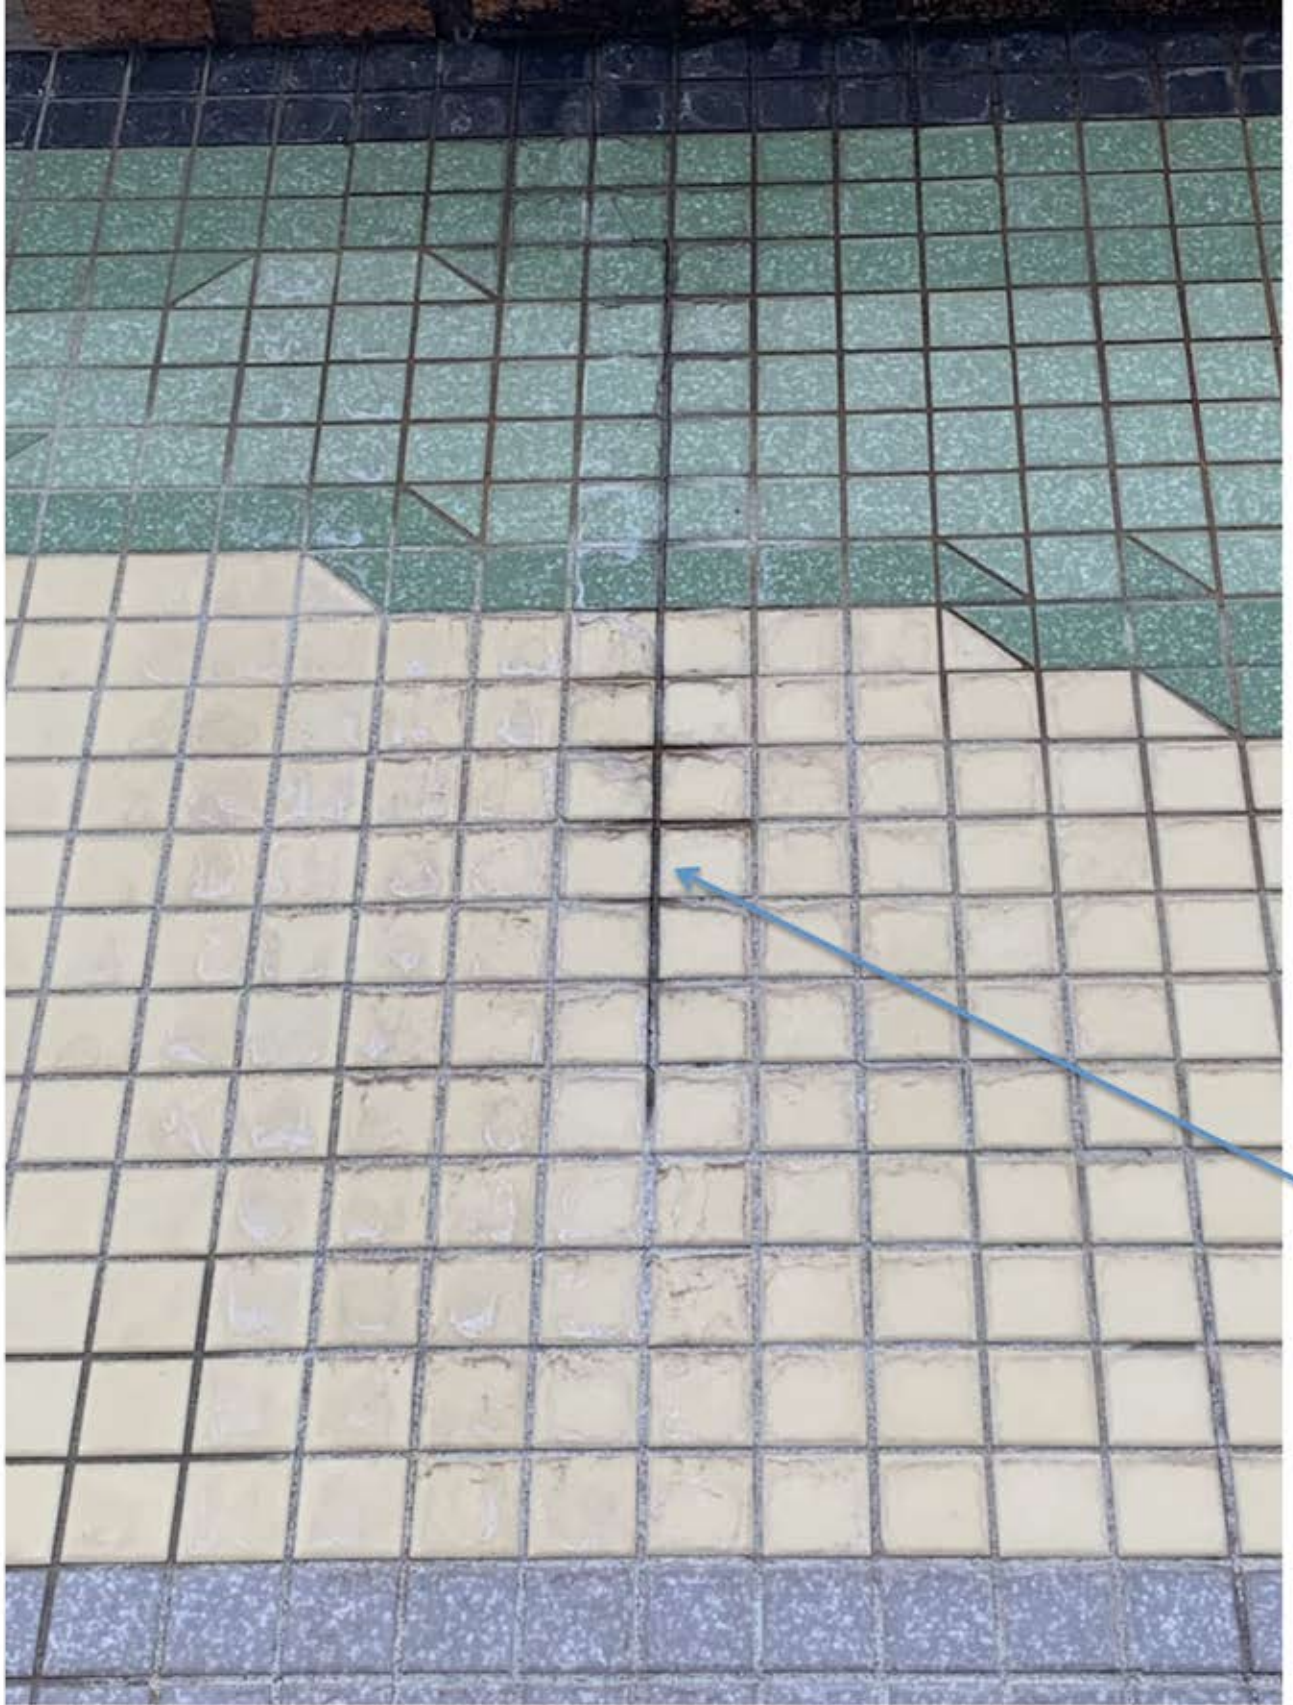
Discolored grout from water damage and mold

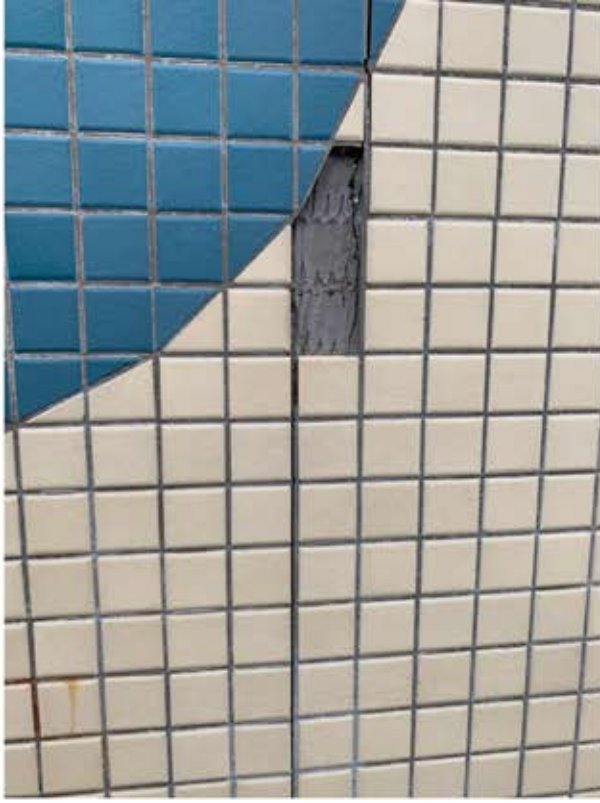
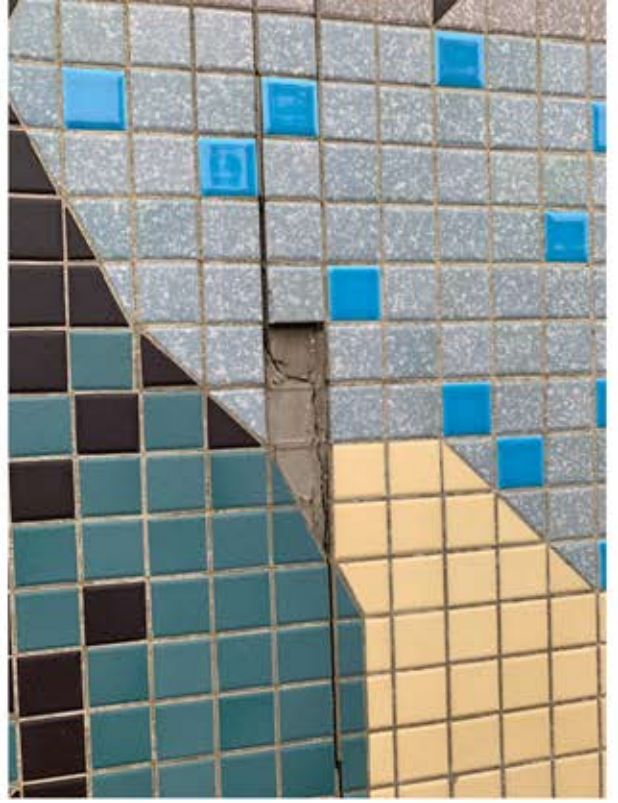
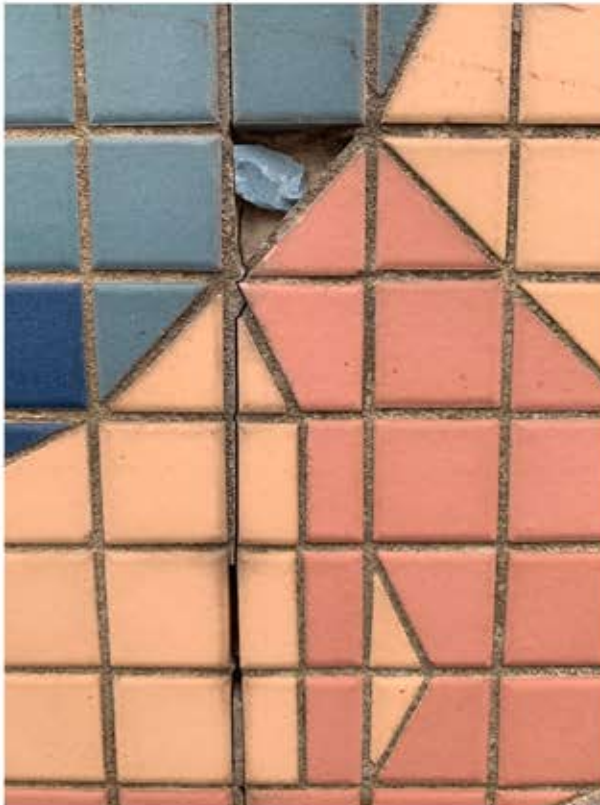
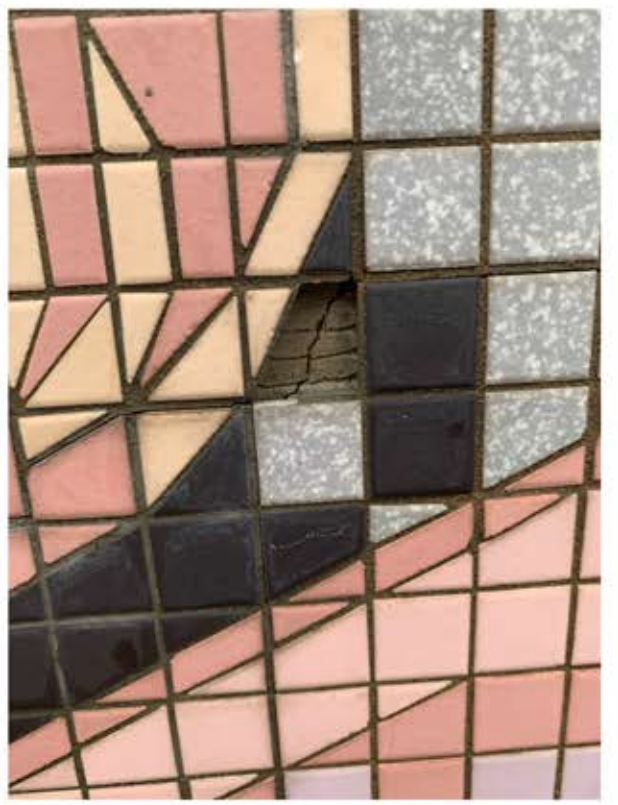
The carrier is 1" ceramic tile in a variety of colors. Several tiles are missing or broken.

Missing tiles.

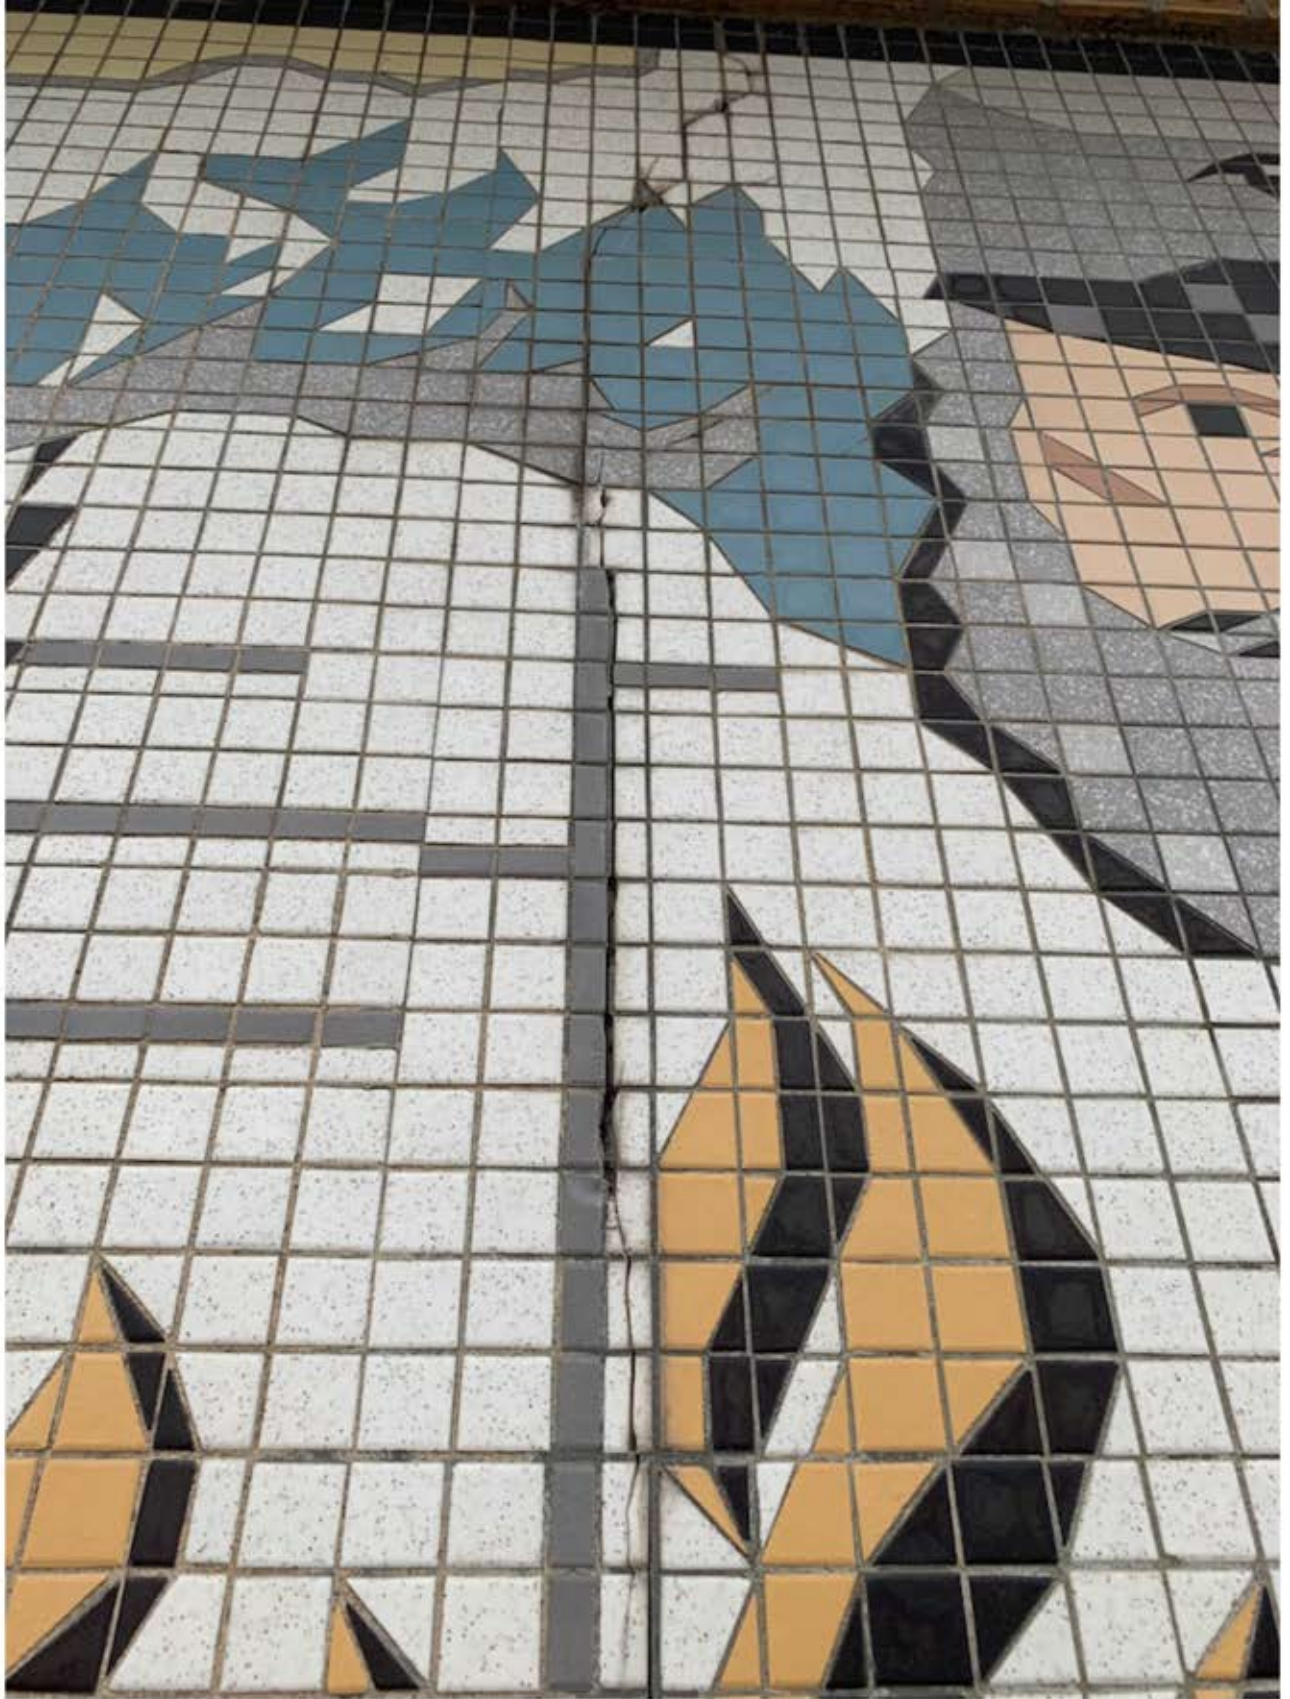
Cracks forming from structural instability

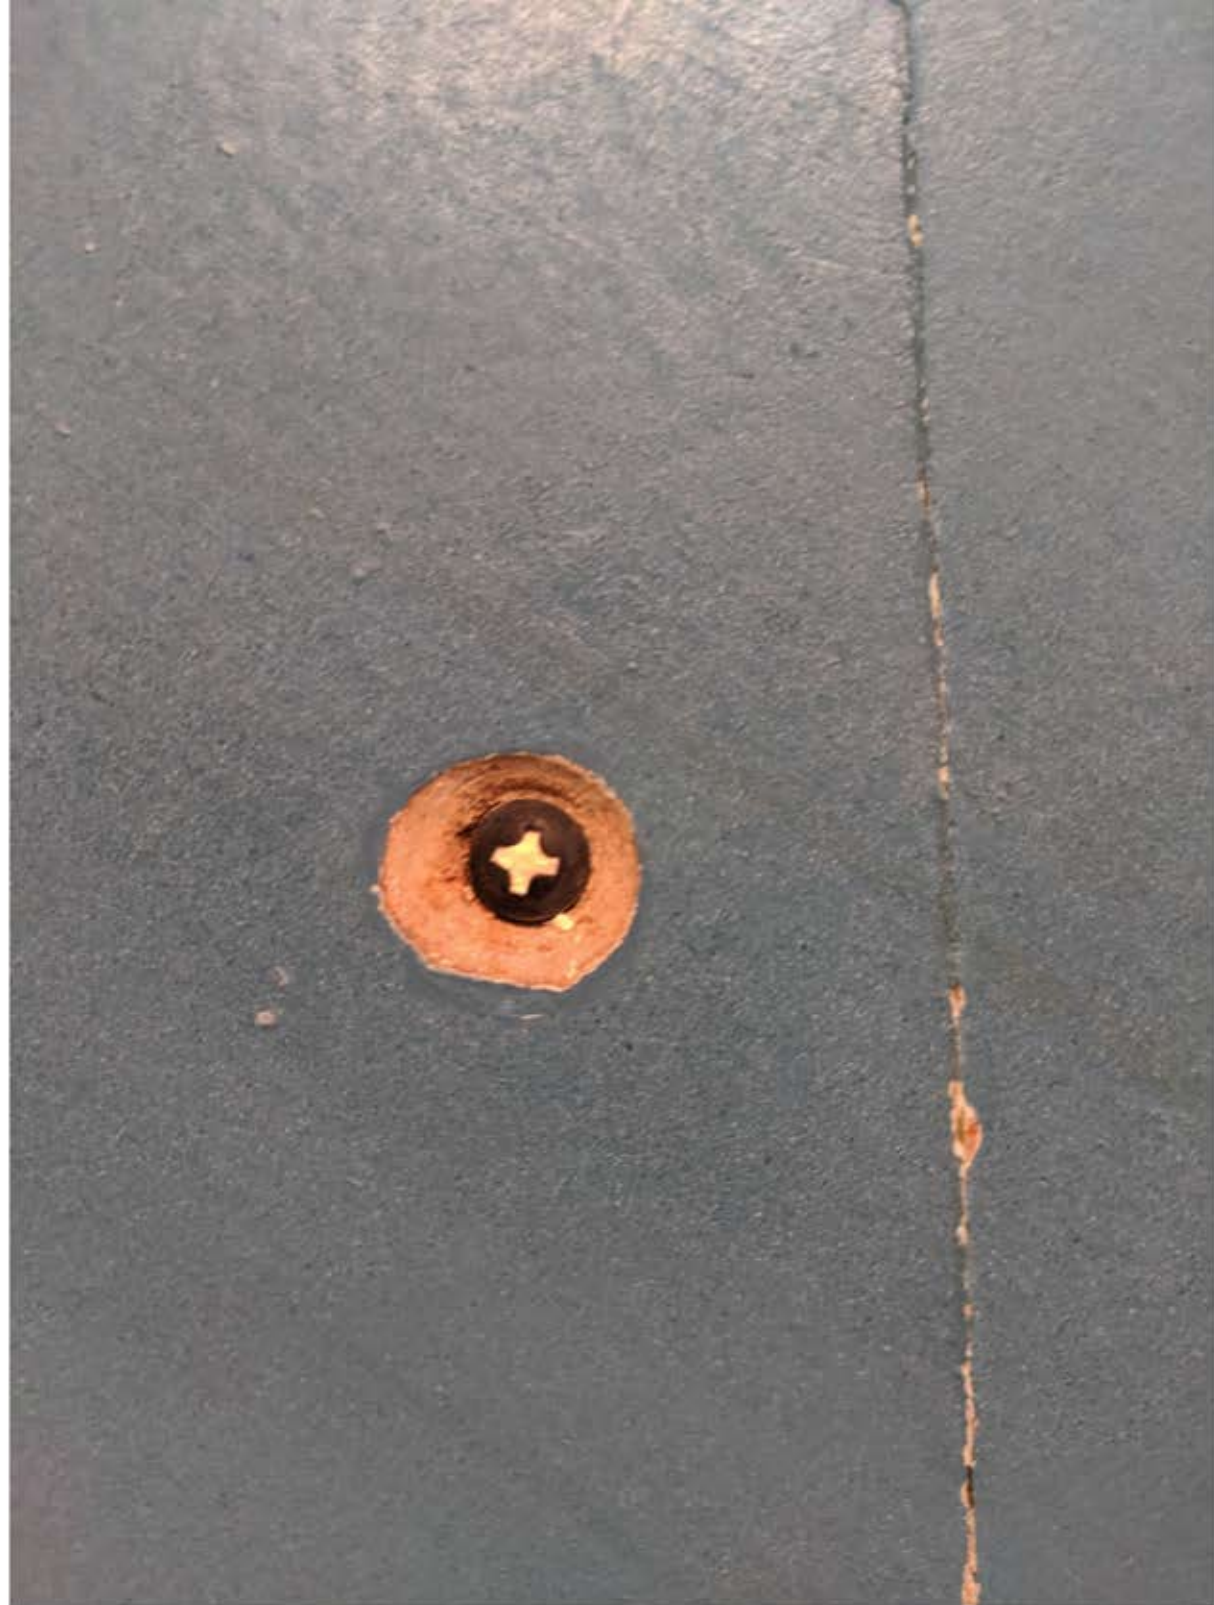
The mural is comprised of eight Masonite panels bolted to the cinderblock wall every 12" by sunken bolts. Each panel measures 48" x 72" and has 16-20 bolts. Totaling around 160 exposed losses. Many of the bolts are exposed; the rest are poorly filled and retouched. Several of the panels are bowing from changes in humidity, especially the fifth panel, creating gaps between the panel seams.

Examples of sunken bolt holes

- Tarp off the area surrounding the mural to allow for on site treatment
- Clean panels with tested surfactant or tri-sodium meta-silicate and clear cleaner with alcohol
- Level raised areas over sunken bolts and raised seams
- Infill bolt losses and seams with conservation-grade acrylic putty; sand and repeat fills as necessary to create smooth surface to match the surround
- Inpaint losses with conservation-grade raw pigments suspended in solvent
- Tent off workspace and spray mural with low-gloss UV varnish to facilitate future cleaning
- Tighten corner gaps in frame with wood glue and/or tacks
- We recommend that the Arts Council hire an electrician(or petition facilities department) to install appropriate lighting for display

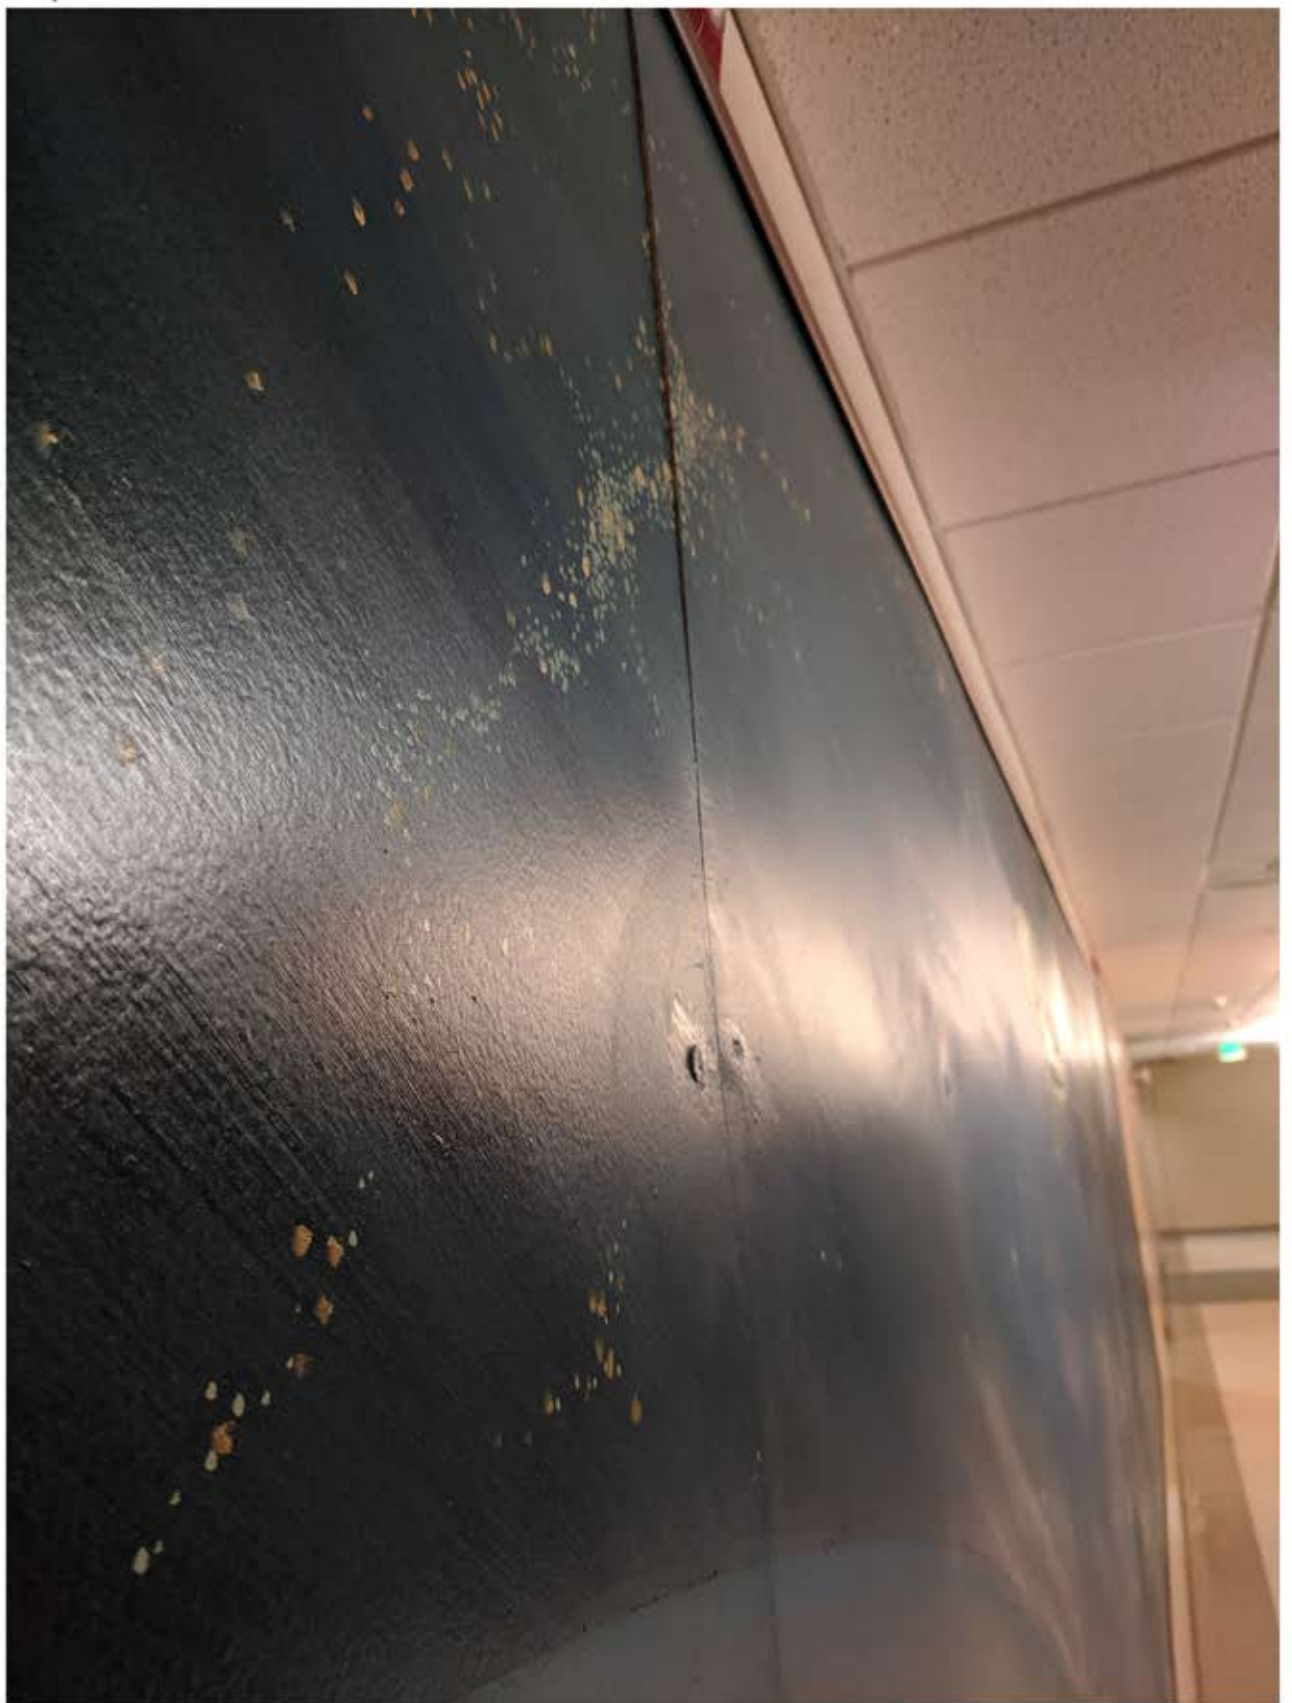
Sample of untreated bolt

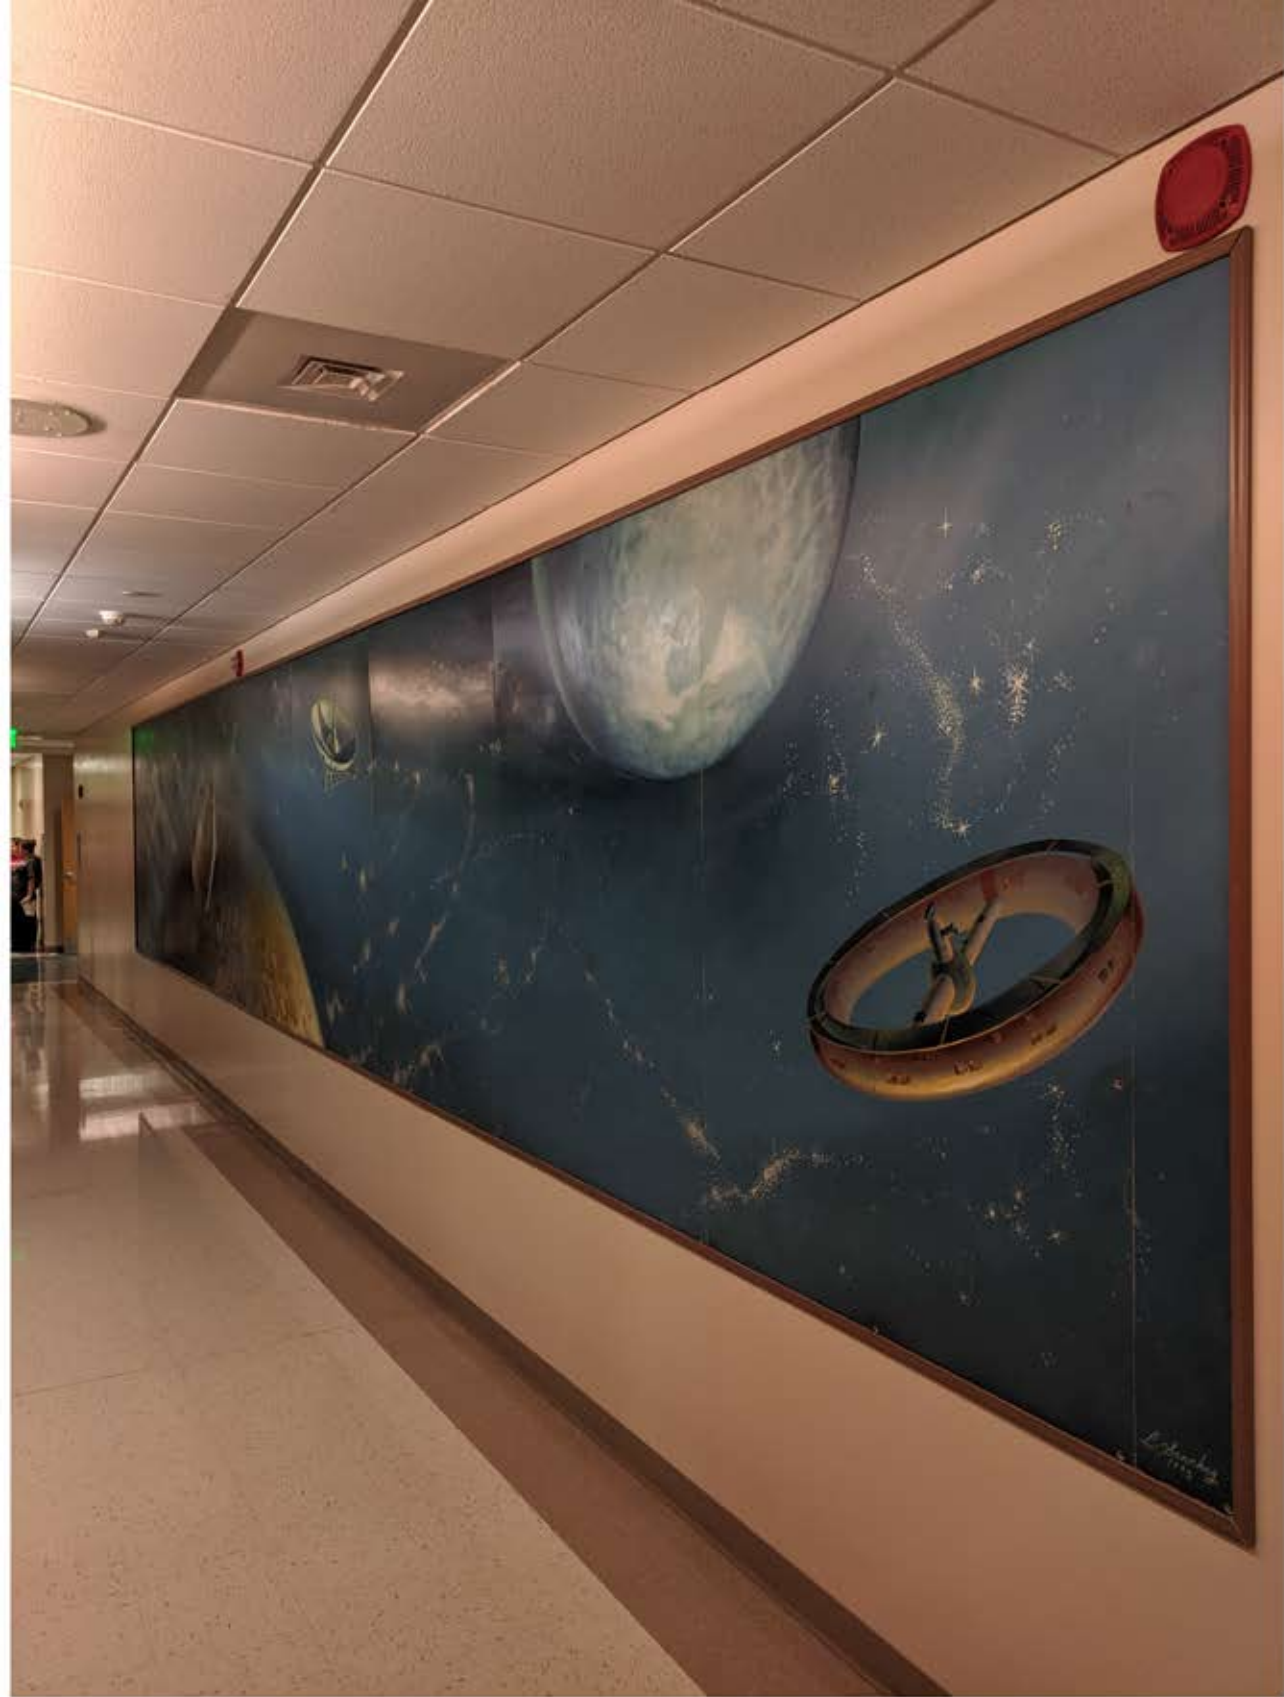
The hallway in which the mural is displayed is poorly lit, and the angle of the lighting accentuates the irregularities on the mural's surface.

Inadequate lighting
