**Title:** Centennial Mural  
**Type:** Oil paint on cotton duck sailcloth  
**Artist:** Duard Marshall  
**Signature:** lower right of all panels, "Duard Marshall 1939"  
**Created:** 1939  
**Size:** 84" x 360"  
**Framed:** Frame has been fabricated, but is not present; mounted with wood collar and strips

(birthplace of Thomas Hart Benton). on-site visit to examine the named mural for conservation, cleaning and restoration. It is displayed at the Neosho Library. Examination was performed with available light, ultraviolet light and microscopic magnification. An aqueous and solvent-based cleaning test was performed. Please refer to this report for the condition in general.

**Title:** Rocketdyne Mural  
**Type:** Acrylic on masonite  
**Artist:** Lawrence Sanchez, Jr.  
**Signature:** bottom right, "L. Sanchez 1963"  
**Created:** 1963  
**Size:** 536" x 107"  
**Framed:** 1" traditional profile, non-structural, medium-brown

Neosho, MO (birthplace of Thomas Hart Benton), on-site visit to examine a mural displayed on a wall in the science wing of Davidson Hall at Crowder College for conservation. Examination was performed with available light, ultraviolet light and microscopic ma

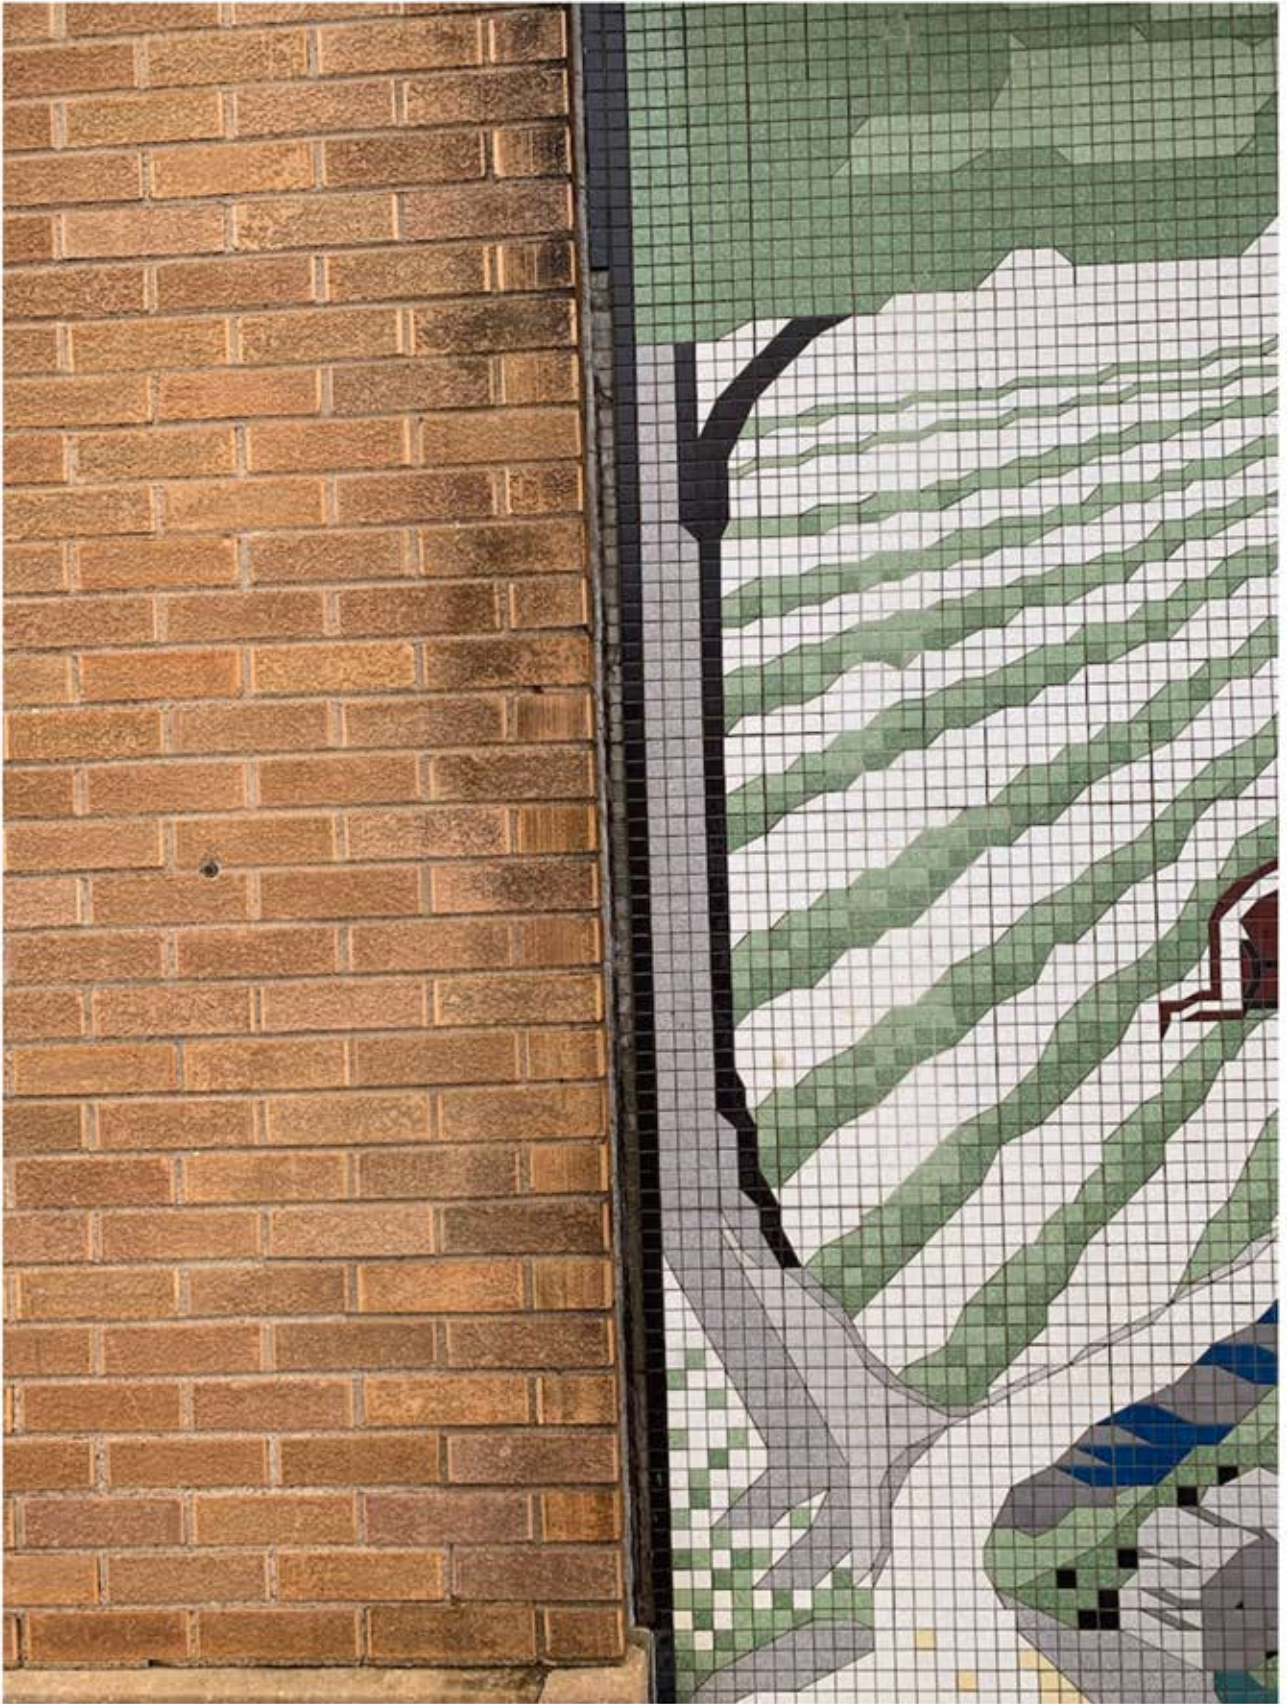
The mural is comprised of 1" ceramic tiles adhered to an exterior wall with mortar. Cracks have formed in the mortar and in some of the tiles, possibly as a result of water damage behind the mortar and/or structural issues with the building. The mural appears to no longer be in plane, again possibly as a result of structural issues with the building. The mortar is discolored and crumbling in multiple areas causing the tile to delaminate and fall to the ground.

*Seal of tile to brick wall is broken and not water tight, tiles are delaminating*

- We advise Neosho Arts Council to engage a local structural engineer or contractor to inspect the building for structural integrity and water damage
- Restoration of the mural is not advised until building and wall have been cleared
- Reproduce missing tiles with new tiles custom-fired to match, depending on availability
- Remove built up grime and mortar from areas where tiles have been lost or removed
- Clean mural with an ionic surfactant
- Remove crumbling grout from the mosaic and repoint and fill losses
- Reinstall missing tile
- Seal grout and wax the mural

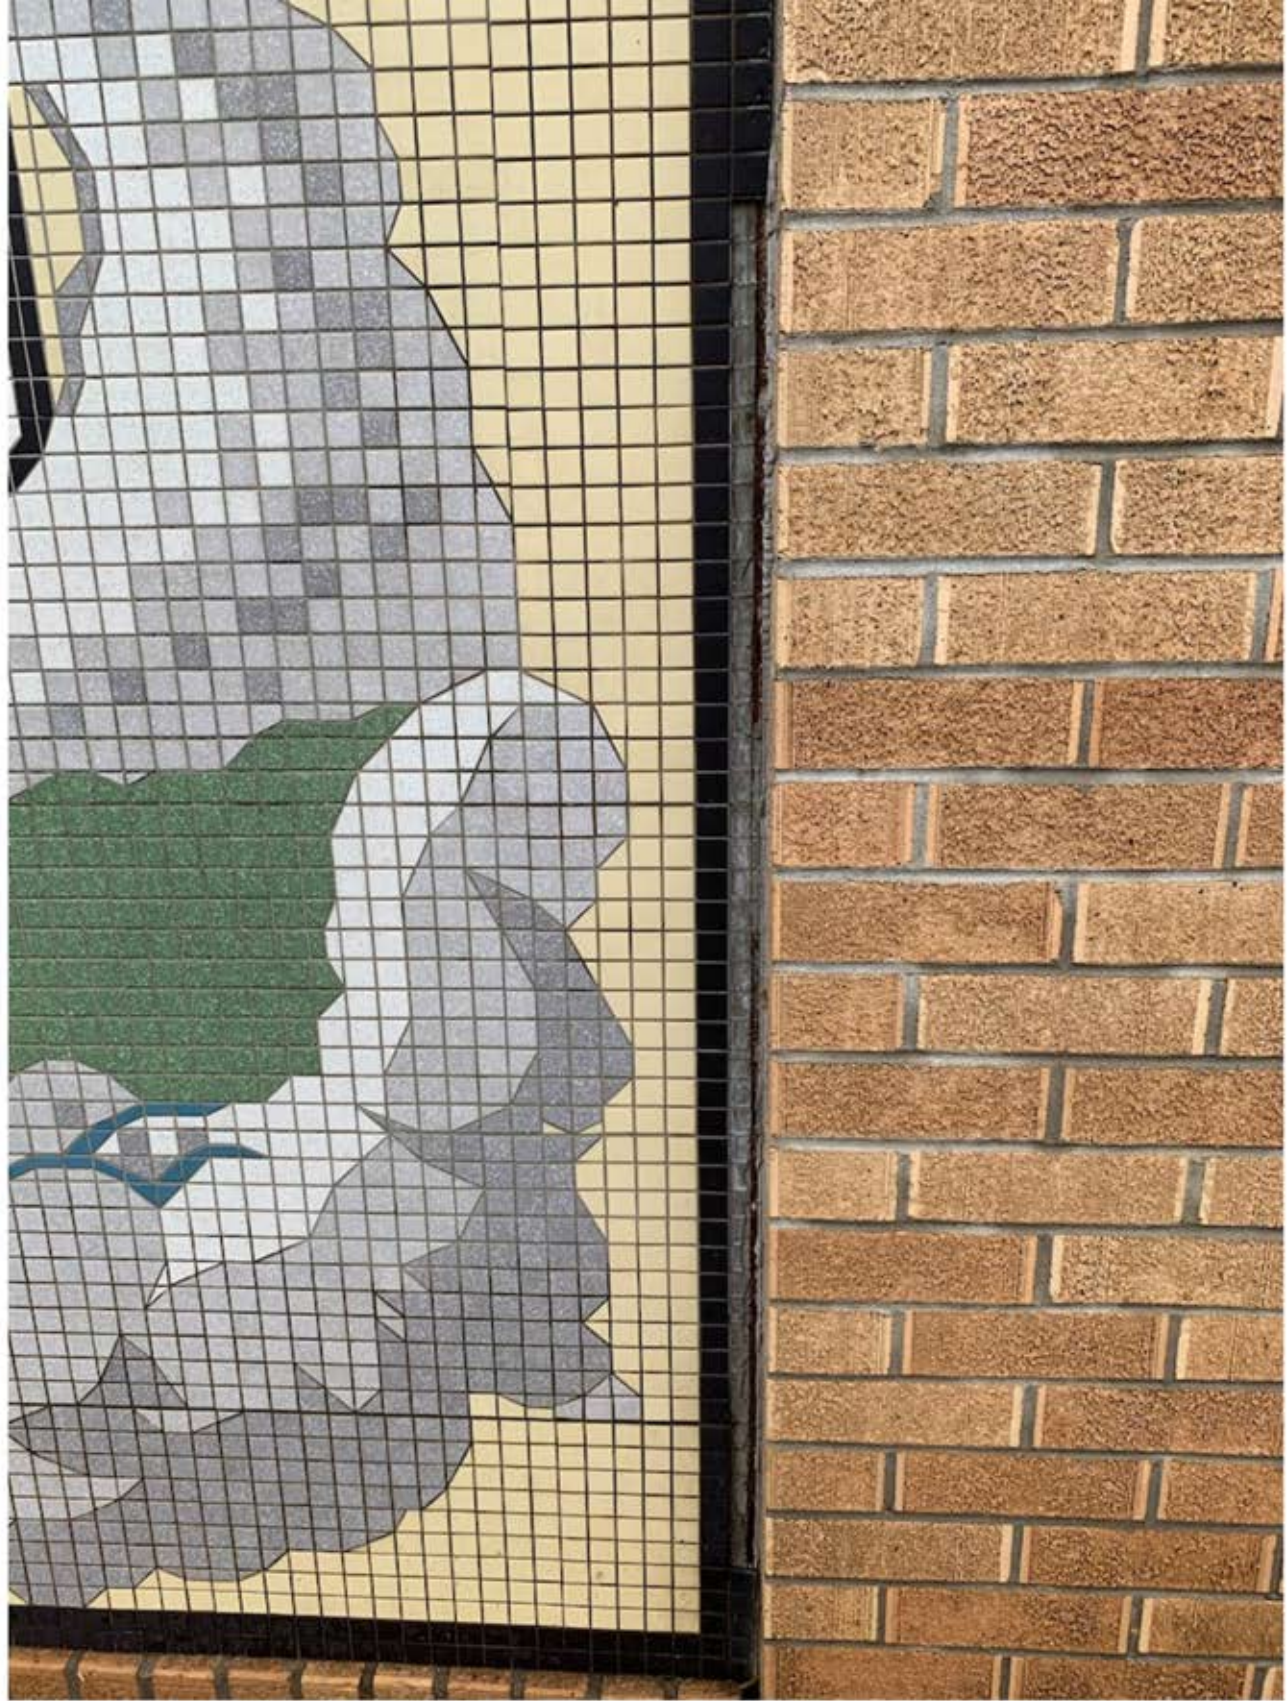
Cracks forming from structural instability

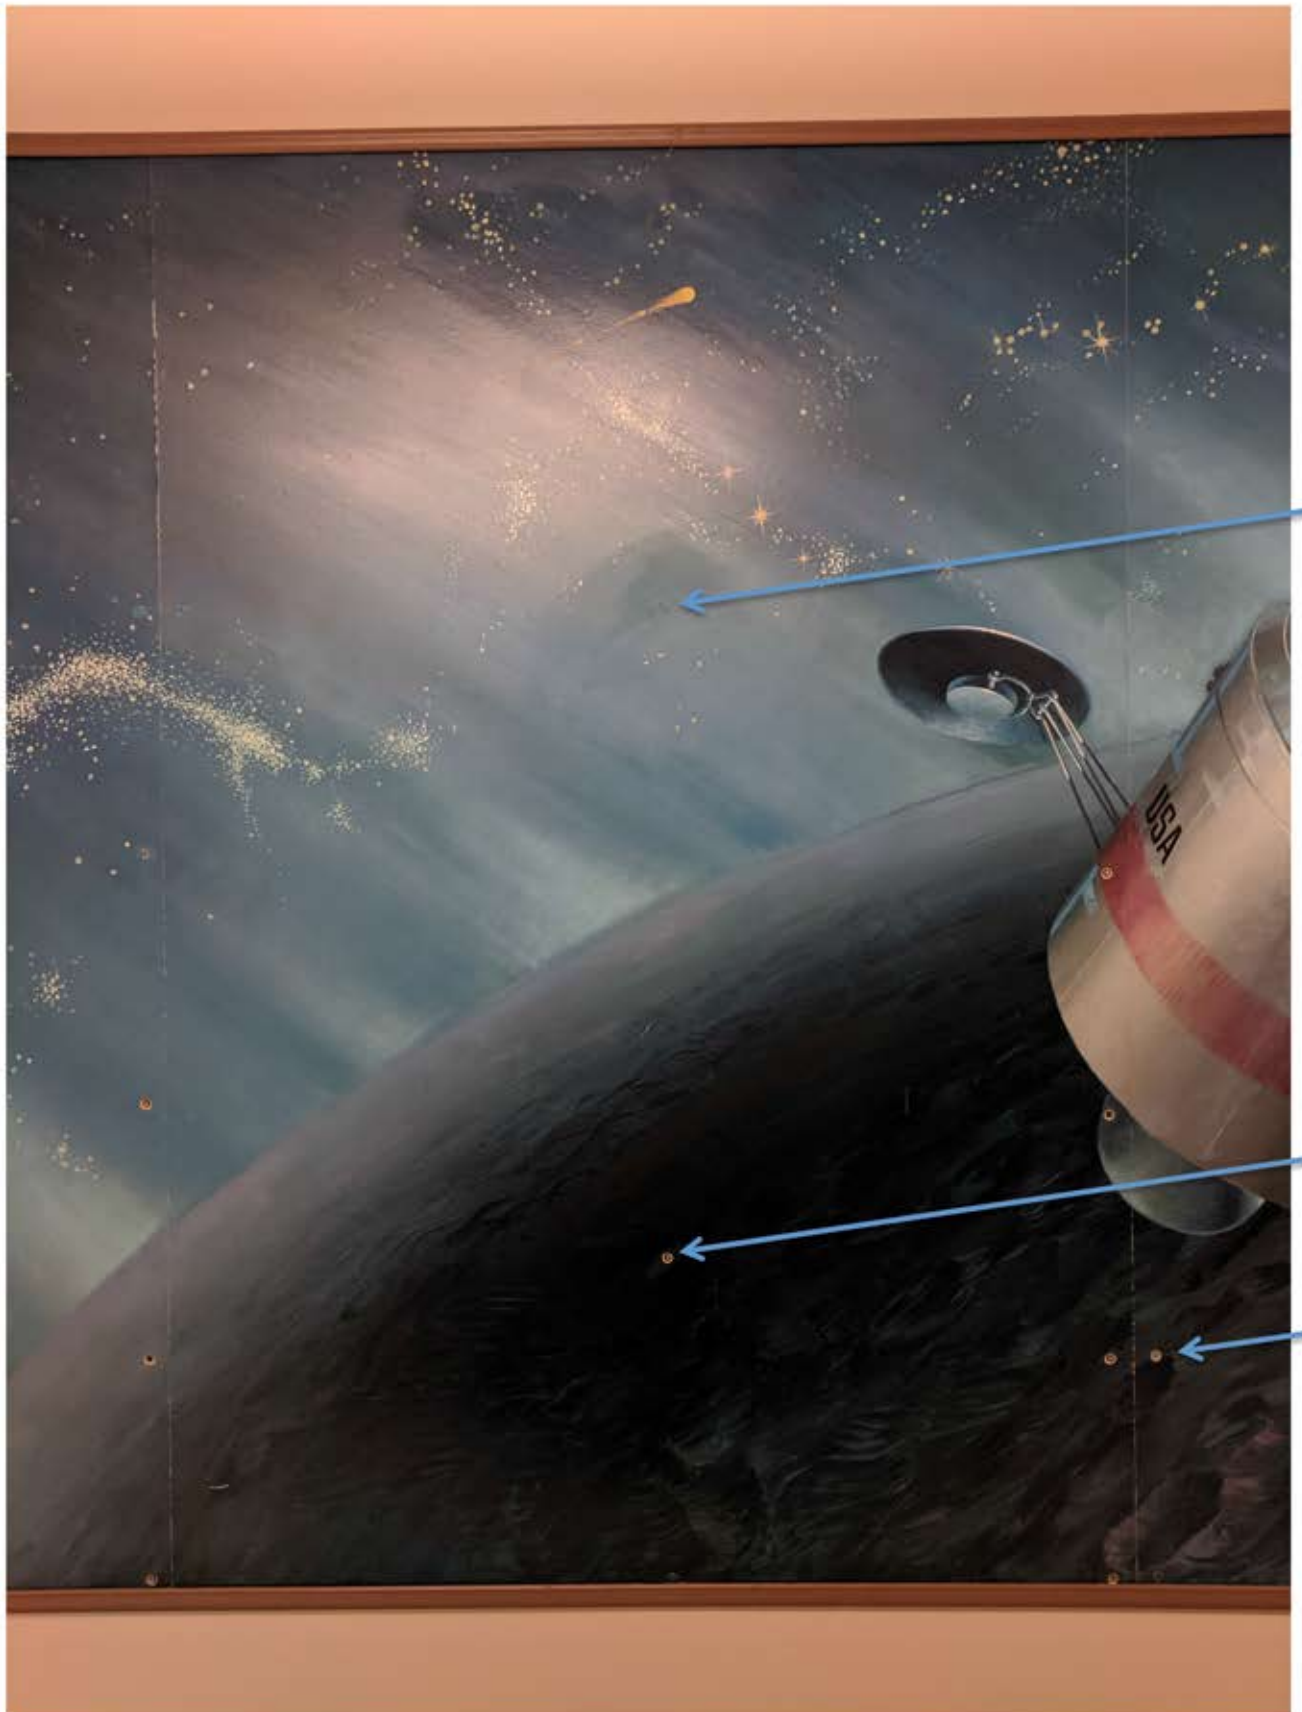
The mural is comprised of eight Masonite panels bolted to the cinderblock wall every 12" by sunken bolts. Each panel measures 48" x 72" and has 16-20 bolts. Totaling around 160 exposed losses. Many of the bolts are exposed; the rest are poorly filled and retouched. Several of the panels are bowing from changes in humidity, especially the fifth panel, creating gaps between the panel seams.

Examples of sunken bolt holes

- Tarp off the area surrounding the mural to allow for on site treatment
- Clean panels with tested surfactant or tri-sodium meta-silicate and clear cleaner with alcohol
- Level raised areas over sunken bolts and raised seams
- Infill bolt losses and seams with conservation-grade acrylic putty; sand and repeat fills as necessary to create smooth surface to match the surround
- Inpaint losses with conservation-grade raw pigments suspended in solvent
- Tent off workspace and spray mural with low-gloss UV varnish to facilitate future cleaning
- Tighten corner gaps in frame with wood glue and/or tacks
- We recommend that the Arts Council hire an electrician(or petition facilities department) to install appropriate lighting for display

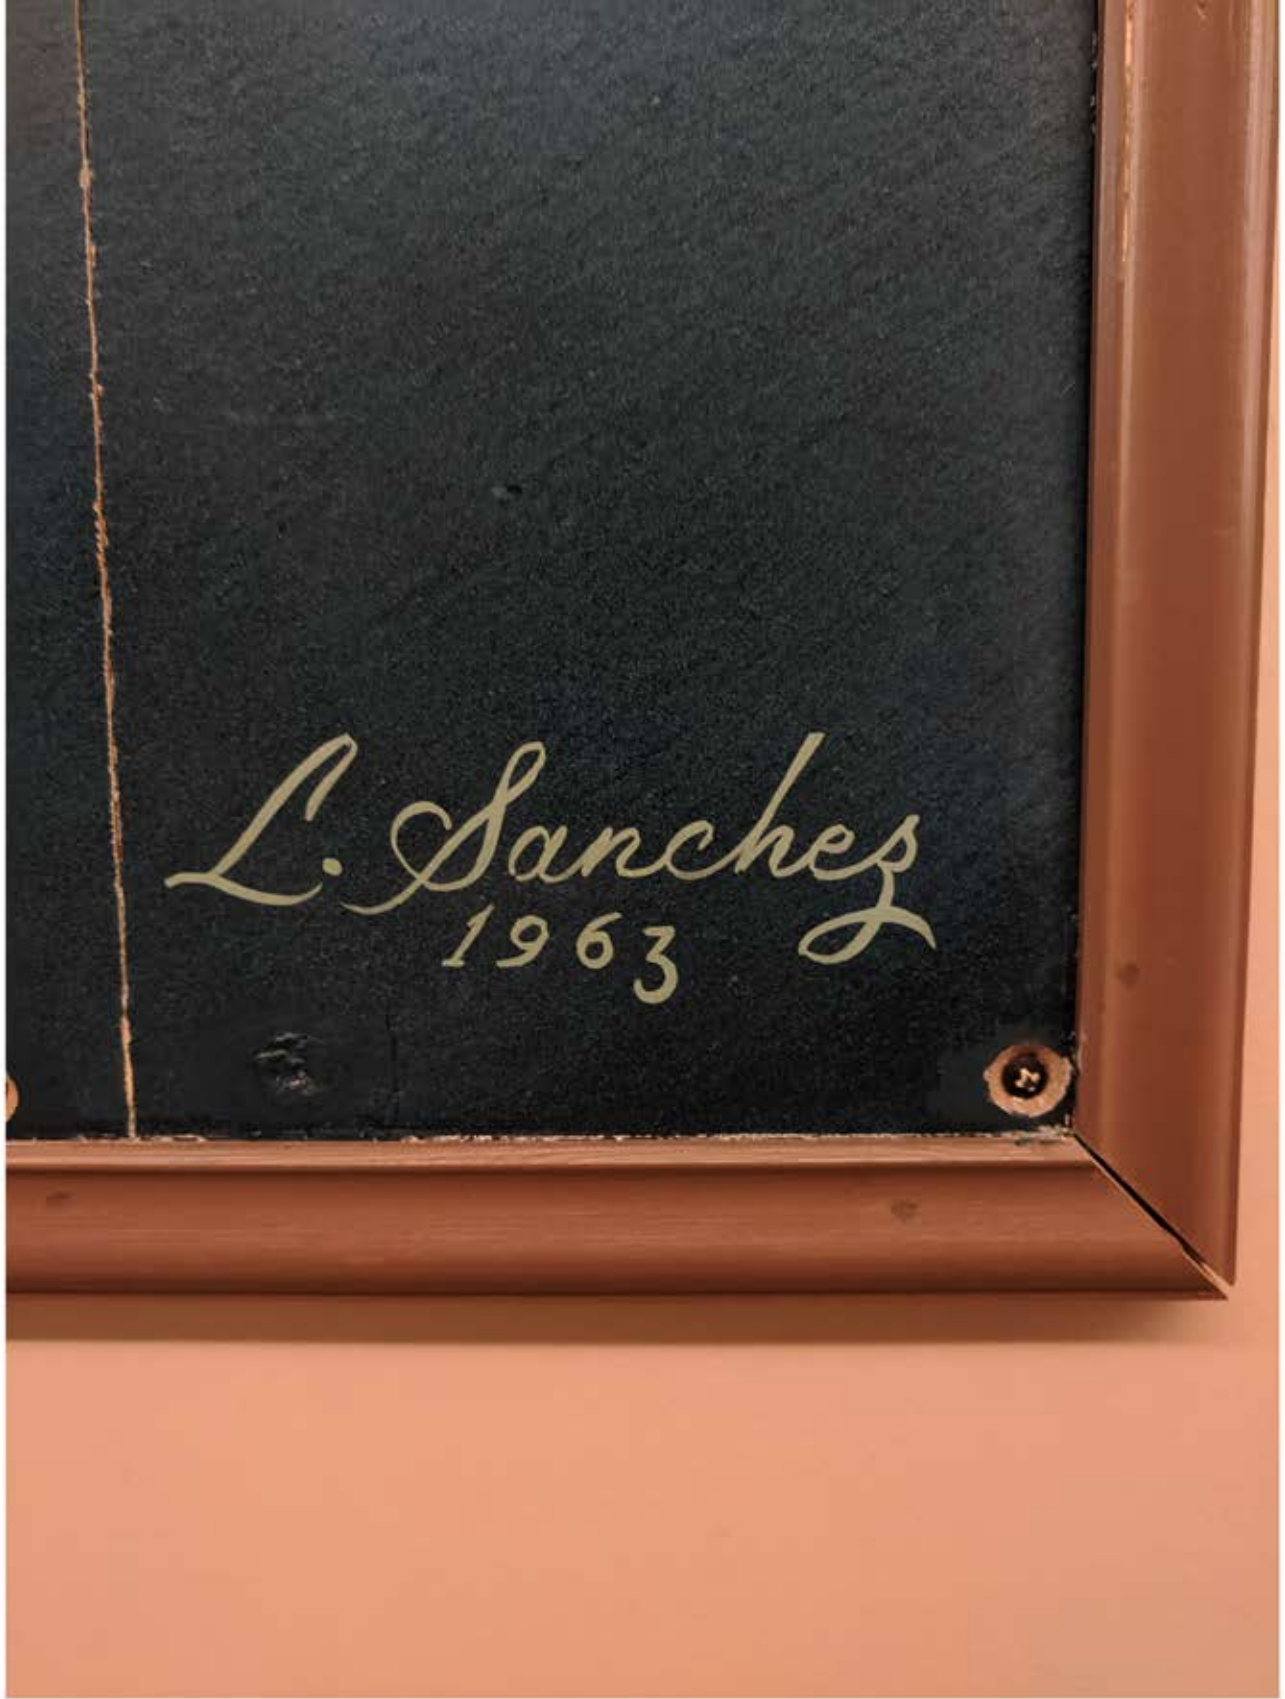
The painting is displayed with a simple non-structural 1" medium-brown frame in a traditional profile. The frame has gapping at the corners, presumably from being improperly remounted after the mural was relocated.

Artist's signature in bottom right corner; note split frame joint
